Access Compliance Report

Public Rights-of-Way

(Curb Ramps)

Intersection ID: 44935	Main Street: NATHAN_DR	Cross Street: REEDMONT_LN	Location: NE
ADA ID: E3551EFD3A94	Ramp Type: PerpDiag	Initial Pass/Fail: Fail	Overall Compliance: No
Severity Score: 12.5			
Codes/Mitigation Info/Possible Solution		Field Measurements/Component Compliance

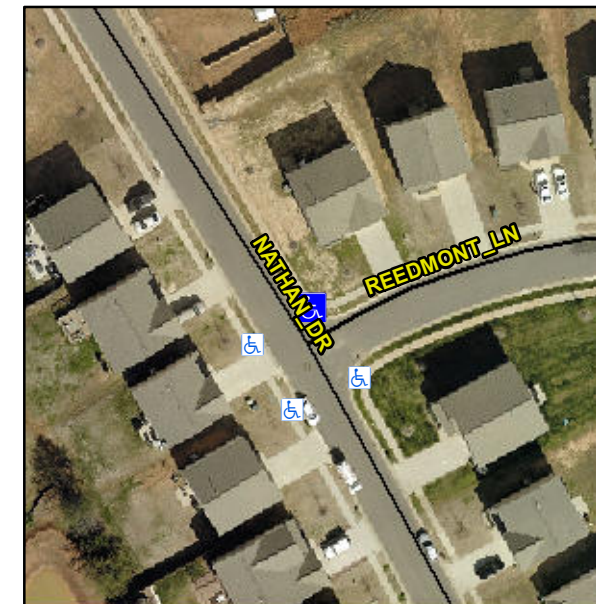
Not Found, R304.2.2

Compliance	Description	Data	Compliance	Description	Data
N/A	Ramp Length (in)	47.5	No	Ramp Slope (%)	9.3
Yes	Ramp Width (in)	48.0	Yes	Ramp XSlope (%)	0.3
N/A	Flare Type LT	N/A	N/A	Flare Type RT	N/A
N/A	Flare Slope LT (%)	N/A	N/A	Flare Slope RT (%)	N/A
N/A	Flare Traversable LT?	N/A	N/A	Flare Traversable RT?	N/A
N/A	Landing Length (in)	N/A	N/A	DWS Provided?	N/A
N/A	Landing Width (in)	N/A	N/A	DWS Contrast?	N/A
N/A	Landing Slope (%)	N/A	N/A	DWS Length (in)	N/A
N/A	Landing X Slope (%)	N/A	N/A	DWS Full Width?	N/A
N/A	Landing Curb? (Y/N)	N/A	N/A	DWS Offset (in)	N/A
N/A	Shared Landing?	N/A			
N/A	Gutter Ponding?	N/A	N/A	Gutter Slope (%)	N/A
N/A	Gutter Lip Ht (in)	N/A	N/A	Gutter X Slope (%)	N/A
N/A	Painted X Walk1?	No	N/A	Painted X Walk2?	No
	X Walk 1 Direction	To W		X Walk 2 Direction	To S
N/A	X Walk 1 Width (in)	N/A	N/A	X Walk 2 Width (in)	N/A
	X Walk 1 Slope (%)	0.2		X Walk 2 Slope (%)	3.2
	X Walk 1 X Slope (%)	1.3		X Walk 2 X Slope (%)	0.7

N/A	Ramp inside XWalk1?	N/A	N/A	Ramp inside XWalk2?	N/A
	Road Slope (%)	1.1	N/A	Clear Space?	N/A
	Road X Slope (%)	2.0	N/A	Clear Space to XWalk (in)	N/A
N/A	Any Obstructions?	N/A	N/A	Storm Grate/Utility Hazard?	N/A
	Obstruction Type			Storm Grate/Utility Type	
		N/A			N/A
			Yes	Surface Condition? (G/P)	Good

Remove & Replace Curb Ramp With Two New Directional Ramps or Equivalent.
