## Access Compliance Report Public Rights-of-Way (Curb Ramps)

Intersection ID: 12505 Main Street: OLD\_STEELE\_CREEK\_RD Cross Street: WESTERLY\_HILLS\_DR Location: SE

ADA ID: E35730C88FBE Ramp Type: Perp Initial Pass/Fail: Fail Overall Compliance: No Severity Score: 8.75

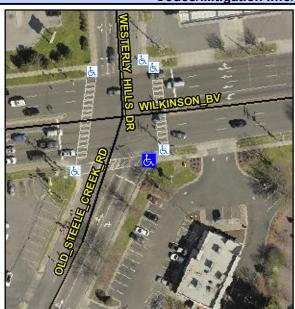
Field Measurements/Component Compilance					
Compliance Description		Data	Compliance Description		Data
N/A	Ramp Length (in)	77.0	Yes	Ramp Slope (%)	7.7
No	Ramp Width (in)	45.0	Yes	Ramp XSlope (%)	1.9
N/A	Flare Type LT	N/A	N/A	Flare Type RT	N/A
N/A	Flare Slope LT (%)	N/A	N/A	Flare Slope RT (%)	N/A
N/A	Flare Traversable LT?	N/A	N/A	Flare Traversable RT?	N/A
N/A	Landing Length (in)	N/A	N/A	DWS Provided?	N/A
N/A	Landing Width (in)	N/A	N/A	DWS Contrast?	N/A
N/A	Landing Slope (%)	N/A	N/A	DWS Length (in)	N/A
N/A	Landing X Slope (%)	N/A	N/A	DWS Full Width?	N/A
N/A	Landing Curb? (Y/N)	N/A	N/A	DWS Offset (in)	N/A
N/A	Shared Landing?	N/A			
N/A	Gutter Ponding?	N/A	N/A	Gutter Slope (%)	N/A
N/A	Gutter Lip Ht (in)	N/A	N/A	Gutter X Slope (%)	N/A
N/A	Painted X Walk1?	Yes	N/A	Painted X Walk2?	N/A
	X Walk 1 Direction	To W		X Walk 2 Direction	N/A
N/A	X Walk 1 Width (in)	107.0	N/A	X Walk 2 Width (in)	N/A
	X Walk 1 Slope (%)	0.8		X Walk 2 Slope (%)	N/A

X Walk 1 X Slope (%)	5.0		X Walk 2 X Slope (%)	N/A
N/A	Ramp inside XWalk1?	Yes	N/A	Ramp inside XWalk2?	N/A
	Road Slope (%)	N/A	N/A	Clear Space?	N/A
	Road X Slope (%)	N/A	N/A	Clear Space to XWalk (in)	N/A
N/A	Any Obstructions?	N/A	N/A	Storm Grate/Utility Hazard?	N/A
	Obstruction Type		l	Storm Grate/Utility Type	
		N/A			N/A
			Yes	Surface Condition? (G/P)	Good

Remove & Replace Entire Ramp.

Total Cost: \$ 1850.00
