Access Compliance Report

Public Rights-of-Way

(Curb Ramps)

Intersection ID: 45488	Main Street: CAPTAIN_ARDREY_RD	Cross Street: GINHOUSE_LN	Location: SW
ADA ID: E361FF2723F8	Ramp Type: Perp	Initial Pass/Fail: Fail	Overall Compliance: No
Severity Score: 26.25			
Codes/Mitigation Info/Possible Solution		Field Measurements/Component Compliance

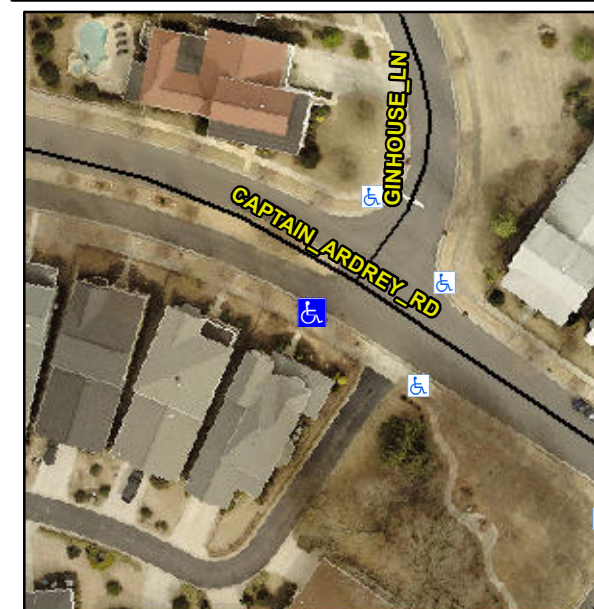
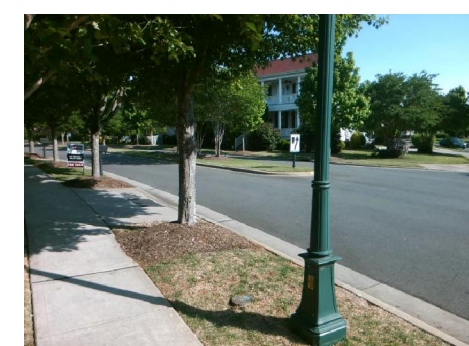
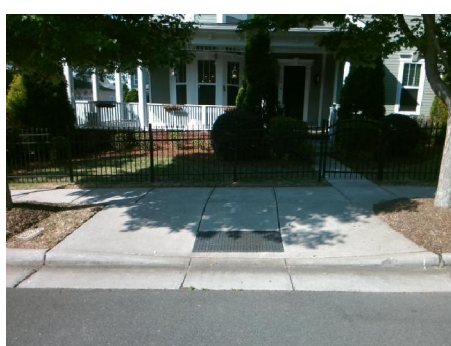
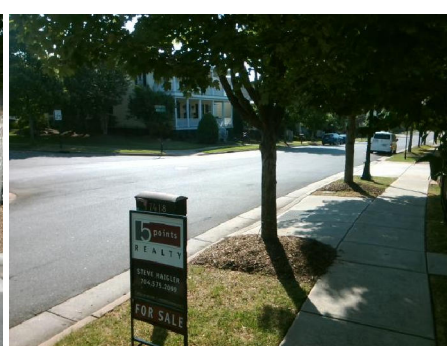
Not Found, R304.2.2

Compliance	Description	Data	Compliance	Description	Data
N/A	Ramp Length (in)	72.0	No	Ramp Slope (%)	12.1
Yes	Ramp Width (in)	48.0	Yes	Ramp XSlope (%)	3.1
N/A	Flare Type LT	N/A	N/A	Flare Type RT	N/A
N/A	Flare Slope LT (%)	N/A	N/A	Flare Slope RT (%)	N/A
N/A	Flare Traversable LT?	N/A	N/A	Flare Traversable RT?	N/A
N/A	Landing Length (in)	N/A	N/A	DWS Provided?	N/A
N/A	Landing Width (in)	N/A	N/A	DWS Contrast?	N/A
N/A	Landing Slope (%)	N/A	N/A	DWS Length (in)	N/A
N/A	Landing X Slope (%)	N/A	N/A	DWS Full Width?	N/A
N/A	Landing Curb? (Y/N)	N/A	N/A	DWS Offset (in)	N/A
N/A	Shared Landing?	N/A			
N/A	Gutter Ponding?	N/A	N/A	Gutter Slope (%)	N/A
N/A	Gutter Lip Ht (in)	N/A	N/A	Gutter X Slope (%)	N/A
N/A	Painted X Walk1?	No	N/A	Painted X Walk2?	N/A
	X Walk 1 Direction	To NE		X Walk 2 Direction	N/A
N/A	X Walk 1 Width (in)	N/A	N/A	X Walk 2 Width (in)	N/A
	X Walk 1 Slope (%)	2.4		X Walk 2 Slope (%)	N/A
	X Walk 1 X Slope (%)	3.8		X Walk 2 X Slope (%)	N/A

N/A	Ramp inside XWalk1?	N/A	N/A	Ramp inside XWalk2?	N/A
	Road Slope (%)	N/A	N/A	Clear Space?	N/A
	Road X Slope (%)	N/A	N/A	Clear Space to XWalk (in)	N/A
N/A	Any Obstructions?	N/A	N/A	Storm Grate/Utility Hazard?	N/A
	Obstruction Type			Storm Grate/Utility Type	
		N/A			N/A
			Yes	Surface Condition? (G/P)	Good

Remove & Replace Entire Ramp.

Total Cost: \$ 1850.00
