Access Compliance Report

Public Rights-of-Way (Curb Ramps)

Intersection ID: 15996	Main Street: CHESTNUT_LAKE_DR	Cross Street: HICKORY_HOLLOW_LN	Location: NW
ADA ID: E36459C7BC42	Ramp Type: Directional1	Initial Pass/Fail: Fail	Overall Compliance: No
		Severity Score: 25

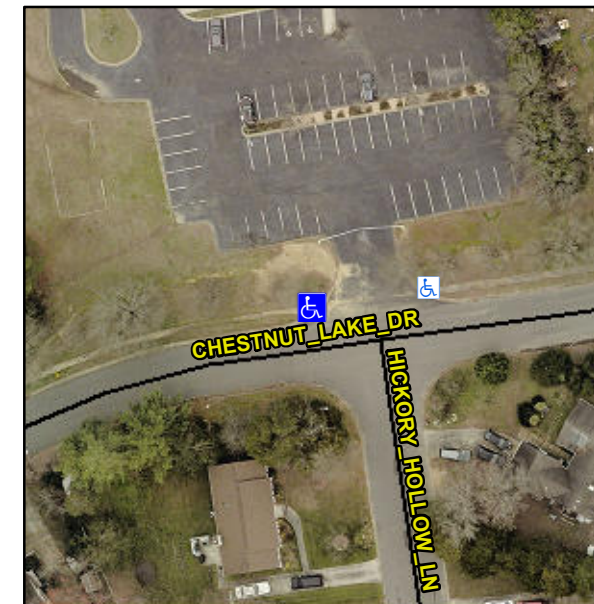
Compliance	Description	Data	Compliance	Description	Data
N/A	Ramp Length (in)	68.0	N/A	Grade Break?	N/A
Yes	Ramp Width (in)	48.0	N/A	Grade Break Slope (%)	0.0
Yes	Ramp Slope (%)	6.2	N/A	Grade Break XSlope (%)	0.0
No	Ramp XSlope (%)	10.8			
N/A	Flare Type LT	N/A	N/A	Flare Type RT	N/A
N/A	Flare Slope LT (%)	N/A	N/A	Flare Slope RT (%)	0.0
N/A	Flare Traversable LT?	N/A	N/A	Flare Traversable RT?	N/A
N/A	Landing Length (in)	0.0	N/A	DWS Provided?	N/A
N/A	Landing Width (in)	0.0	N/A	DWS Contrast?	N/A
N/A	Landing Slope (%)	0.0	N/A	DWS Length (in)	N/A
N/A	Landing X Slope (%)	0.0	N/A	DWS Full Width?	N/A
N/A	Landing Curb? (Y/N)	N/A	N/A	DWS Offset LT (in)	N/A
N/A	Shared Landing?	N/A	N/A	DWS Offset RT (in)	N/A
N/A	Gutter Ponding?	0.0	N/A	Gutter Slope (%)	N/A
N/A	Gutter Lip Ht (in)	0.0	N/A	Gutter X Slope (%)	N/A
N/A	Painted X Walk1?	No		Road Slope (%)	1.2
	X Walk 1 Direction	To E		Road X Slope (%)	1.1
	X Walk 1 Width (in)	N/A		Clear Space?	N/A

X Walk 1 Slope (%)	1.2	N/A	Clear Space to XWalk (in)	N/A
	X Walk 1 X Slope (%)	1.1	N/A	Storm Grate/Utility Hazard?	N/A
N/A	Ramp inside XWalk1?	N/A		Storm Grate/Utility Type	
N/A	Any Obstructions?	N/A			N/A
	Obstruction Type		Yes	Surface Condition? (G/P)	Good
			N/A	Curb Slope (%)	2.4

Possible Solutions:

Remove & Replace Entire Ramp.

PROW/ADA:

R304.5.3

Total Cost:

\$ 1600.00
