# Access Compliance Report

## Public Rights-of-Way

### (Curb Ramps)

Intersection ID: 10798	Main Street: W_5TH_ST	Cross Street: N_BRUNS_AV	Location:	N
ADA ID: E364F2A57085	Ramp Type: PerpDiag	Initial Pass/Fail: Fail	Overall Compliance: No	Severity Score: 12.5

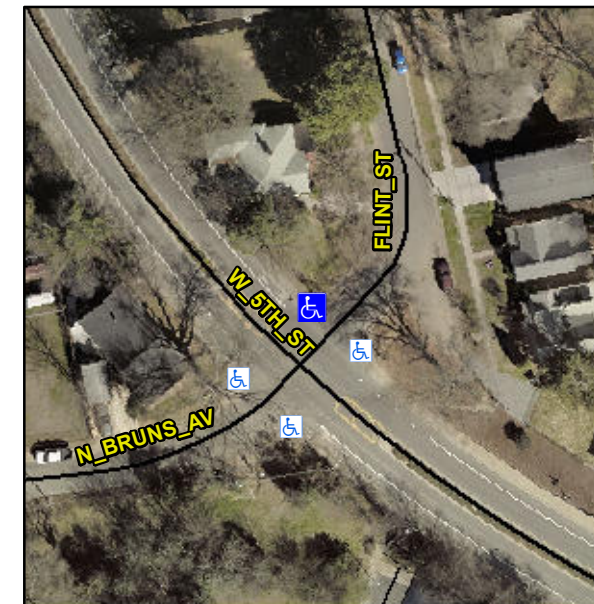
**Not Found, R304.2.2**

Compliance	Description	Data	Compliance	Description	Data
N/A	Ramp Length (in)	66.0	No	Ramp Slope (%)	11.1
Yes	Ramp Width (in)	64.0	Yes	Ramp XSlope (%)	0.1
N/A	Flare Type LT	N/A	N/A	Flare Type RT	N/A
N/A	Flare Slope LT (%)	N/A	N/A	Flare Slope RT (%)	N/A
N/A	Flare Traversable LT?	N/A	N/A	Flare Traversable RT?	N/A
N/A	Landing Length (in)	N/A	N/A	DWS Provided?	N/A
N/A	Landing Width (in)	N/A	N/A	DWS Contrast?	N/A
N/A	Landing Slope (%)	N/A	N/A	DWS Length (in)	N/A
N/A	Landing X Slope (%)	N/A	N/A	DWS Full Width?	N/A
N/A	Landing Curb? (Y/N)	N/A	N/A	DWS Offset (in)	N/A
N/A	Shared Landing?	N/A			
N/A	Gutter Ponding?	N/A	N/A	Gutter Slope (%)	N/A
N/A	Gutter Lip Ht (in)	N/A	N/A	Gutter X Slope (%)	N/A
N/A	Painted X Walk1?	No	N/A	Painted X Walk2?	No
	X Walk 1 Direction	To SW		X Walk 2 Direction	To SE
N/A	X Walk 1 Width (in)	N/A	N/A	X Walk 2 Width (in)	N/A
	X Walk 1 Slope (%)	2.7		X Walk 2 Slope (%)	2.7
	X Walk 1 X Slope (%)	3.6		X Walk 2 X Slope (%)	1.1

N/A	Ramp inside XWalk1?	N/A	N/A	Ramp inside XWalk2?	N/A
	Road Slope (%)	1.8	N/A	Clear Space?	N/A
	Road X Slope (%)	3.3	N/A	Clear Space to XWalk (in)	N/A
N/A	Any Obstructions?	N/A	N/A	Storm Grate/Utility Hazard?	N/A
	Obstruction Type			Storm Grate/Utility Type	
		N/A			N/A
			Yes	Surface Condition? (G/P)	Good

**Remove & Replace Curb Ramp With Two New Directional Ramps or Equivalent.**
