Access Compliance Report Public Rights-of-Way (Curb Ramps)

Intersection ID: 22092 Main Street: SHARON VIEW RD Cross Street: ROCK CREEK DR Location: W Ramp Type: BlendTrans1 Initial Pass/Fail: Pass **Overall Compliance: No Severity Score:** 5.25 ADA ID: E36D48FDE0B3

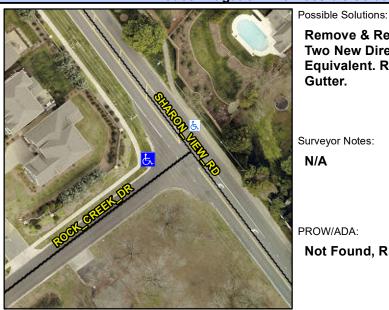
Not Found, R304.5.3, R304.5.4

Compliance Description		Data	Comp	liance Description	Data
N/A	Ramp Length (in)	122.0	Yes	BlendTrans Slope (%)	1.9
Yes	Ramp Width (in)	61.0	No	BlendTrans XSlope (%)	3.0
N/A	Flare Type LT	Sloped	N/A	Flare Type RT	Sloped
N/A	Flare Slope LT (%)	2.9	N/A	Flare Slope RT (%)	5.2
N/A	Flare Traversable LT?	No	N/A	Flare Traversable RT?	No
Yes	Landing Length (in)	48.0	Yes	DWS Provided?	Yes
Yes	Landing Width (in)	57.0	Yes	DWS Contrast?	Yes
Yes	Landing Slope (%)	0.6	Yes	DWS Length (in)	24.0
Yes	Landing X Slope (%)	1.8	Yes	DWS Full Width?	Yes
N/A	Landing Curb? (Y/N)	No	Yes	DWS Offset (in)	0.0
N/A	Shared Landing?	No			
Yes	Gutter Ponding?	No	No	Gutter Slope (%)	6.8
Yes	Gutter Lip Ht (in)	0.0	Yes	Gutter X Slope (%)	0.9
N/A	Painted X Walk1?	No	N/A	Painted X Walk2?	No
	X Walk 1 Direction	To SE		X Walk 2 Direction	To NE
	X Walk 1 Width (in)	N/A		X Walk 2 Width (in)	N/A
	X Walk 1 Slope (%)	0.5		X Walk 2 Slope (%)	0.4
	X Walk 1 X Slope (%)	1.1		X Walk 2 X Slope (%)	1.7

N/A	Ramp inside XWalk1?	N/A	N/A	Ramp inside XWalk2?	N/A
	Road Slope (%)	0.6		Clear Space?	Yes
	Road X Slope (%)	1.2	N/A	Clear Space to XWalk (in)	N/A
Yes	Any Obstructions?	No	Yes	Storm Grate/Utility Hazard?	No
	Obstruction Type			Storm Grate/Utility Type	
		N/A			N/A
			Yes	Surface Condition? (G/P)	Good
			No	Curb Slope (%)	17.1

Remove & Replace Curb Ramp With Two New Directional Ramps or Equivalent. Remove & Replace Gutter.
