Access Compliance Report

Public Rights-of-Way

(Curb Ramps)

Intersection ID: 31219	Main Street: HEADQUARTERS_FARM_RD	Cross Street: WESTBURY_GLEN_CT	Location: NW
ADA ID: E374451E0AFB	Ramp Type: Perp	Initial Pass/Fail: Fail	Overall Compliance: No
Severity Score: 17.5			
Codes/Mitigation Info/Possible Solution		Field Measurements/Component Compliance

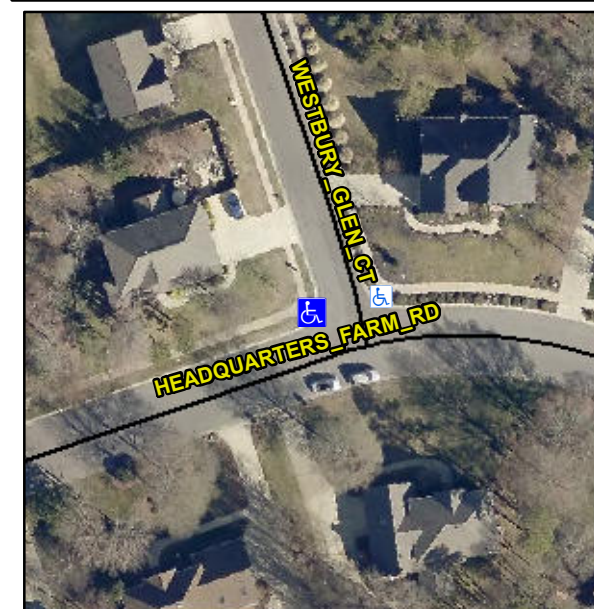
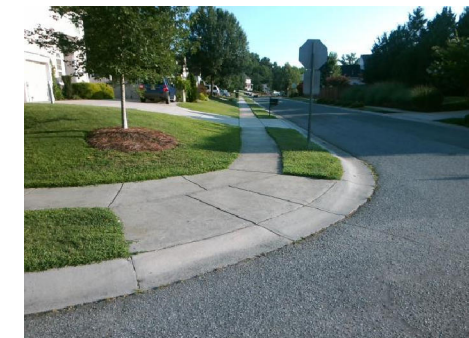
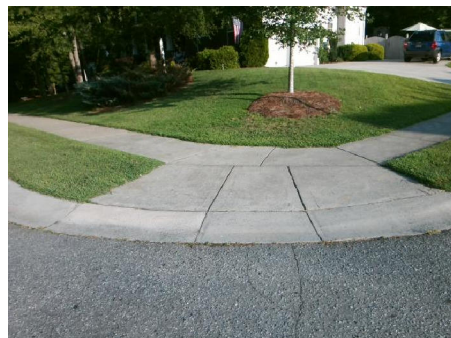
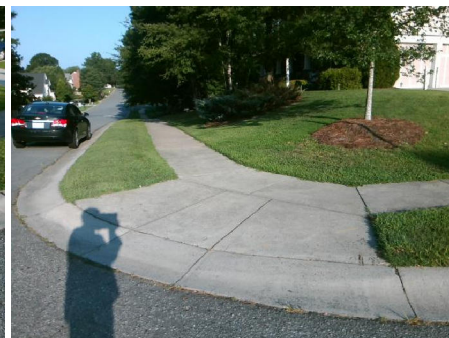
Not Found, R304.5.1

Compliance	Description	Data	Compliance	Description	Data
N/A	Ramp Length (in)	66.0	Yes	Ramp Slope (%)	5.0
No	Ramp Width (in)	33.0	Yes	Ramp XSlope (%)	1.1
N/A	Flare Type LT	N/A	N/A	Flare Type RT	N/A
N/A	Flare Slope LT (%)	N/A	N/A	Flare Slope RT (%)	N/A
N/A	Flare Traversable LT?	N/A	N/A	Flare Traversable RT?	N/A
N/A	Landing Length (in)	N/A	N/A	DWS Provided?	N/A
N/A	Landing Width (in)	N/A	N/A	DWS Contrast?	N/A
N/A	Landing Slope (%)	N/A	N/A	DWS Length (in)	N/A
N/A	Landing X Slope (%)	N/A	N/A	DWS Full Width?	N/A
N/A	Landing Curb? (Y/N)	N/A	N/A	DWS Offset (in)	N/A
N/A	Shared Landing?	N/A			
N/A	Gutter Ponding?	N/A	N/A	Gutter Slope (%)	N/A
N/A	Gutter Lip Ht (in)	N/A	N/A	Gutter X Slope (%)	N/A
N/A	Painted X Walk1?	No	N/A	Painted X Walk2?	N/A
	X Walk 1 Direction	To E		X Walk 2 Direction	N/A
N/A	X Walk 1 Width (in)	N/A	N/A	X Walk 2 Width (in)	N/A
	X Walk 1 Slope (%)	3.6		X Walk 2 Slope (%)	N/A
	X Walk 1 X Slope (%)	1.9		X Walk 2 X Slope (%)	N/A

N/A	Ramp inside XWalk1?	N/A	N/A	Ramp inside XWalk2?	N/A
	Road Slope (%)	N/A	N/A	Clear Space?	N/A
	Road X Slope (%)	N/A	N/A	Clear Space to XWalk (in)	N/A
N/A	Any Obstructions?	N/A	N/A	Storm Grate/Utility Hazard?	N/A
	Obstruction Type			Storm Grate/Utility Type	
		N/A			N/A
		Yes		Surface Condition? (G/P)	Good

Possible Solutions:

Remove & Replace Entire Ramp.

Total Cost: \$ 1850.00
