# Access Compliance Report

## Public Rights-of-Way

| Intersection ID: 26025 | Main Street: CARMEL COMMONS BV | Cross Street: CARMEL RD | Location: SW |
| ADA ID: E3795D542657 | Ramp Type: PerpDiag | Initial Pass/Fail: Fail | Overall Compliance: No |

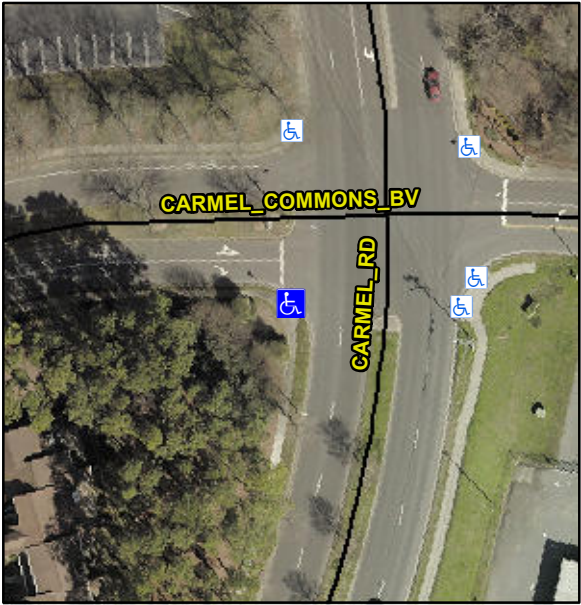
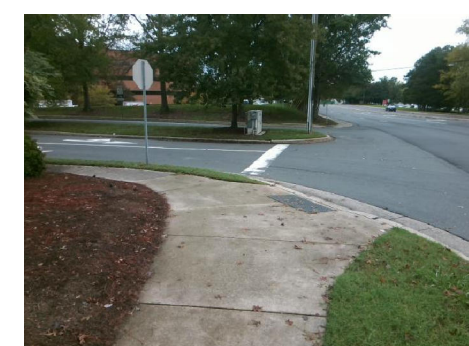
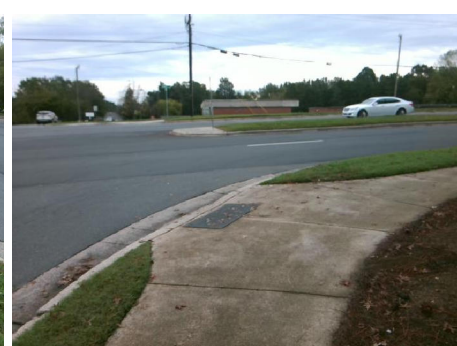
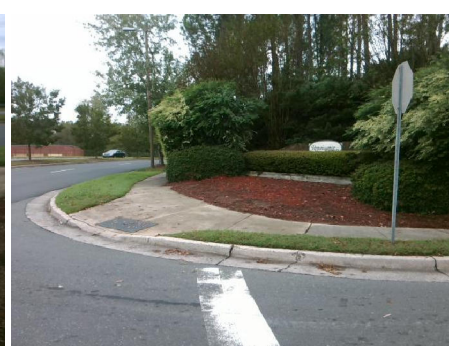
| Codes/Mitigation Info/Possible Solution | | | Field Measurements/Component Compliance | | | |
|---|---|--|---|---|---|---|
| | <b>Remove &amp; Replace Curb Ramp With Two New Directional Ramps or Equivalent.</b> | | N/A | Ramp Length (in) | 117.0 | No |
| | | | Yes | Ramp Width (in) | 48.0 | No |
| <p>Surveyor Notes:</p> <p><b>N/A</b></p> <p>PROW/ADA:</p> <p><b>R304.2.2, R304.5.3</b></p> | | | N/A | Flare Type RT | N/A | N/A |

| Codes/Mitigation Info/Possible Solution | | | Field Measurements/Component Compliance | | | |
|---|---|--|---|---|---|---|
| <p>Total Cost:</p> <p><b>\$ 3200.00</b></p> | | | N/A | Painted X Walk1? | No | N/A |
