Access Compliance Report

Public Rights-of-Way

(Curb Ramps)

Intersection ID: 2909	Main Street: EASTFIELD_RD	Cross Street: EASTFIELD_RD	Location:	E
ADA ID: E3796AD99CEB	Ramp Type: Perp	Initial Pass/Fail: Fail	Overall Compliance: No	Severity Score: 10

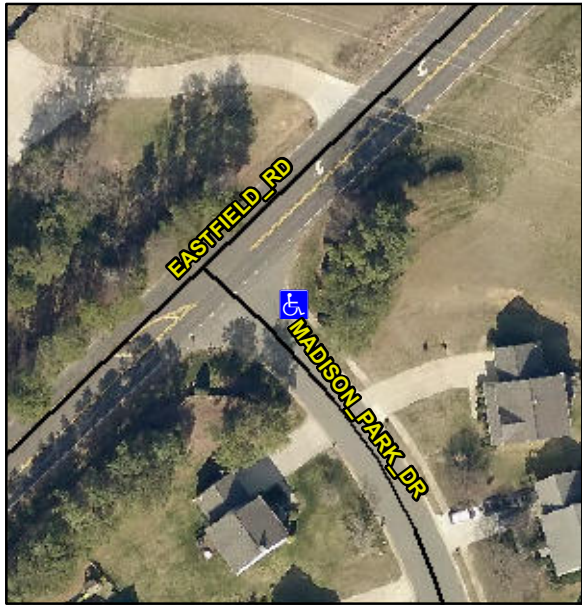
Possible Solutions:		Compliance	Description	Data	Compliance	Description	Data
	Remove & Replace Entire Ramp.		N/A	Ramp Length (in)	45.0	Yes	Ramp Slope (%)	7.7
			No	Ramp Width (in)	46.0	No	Ramp XSlope (%)	2.6
			N/A	Flare Type LT	N/A	N/A	Flare Type RT	N/A
			N/A	Flare Slope LT (%)	N/A	N/A	Flare Slope RT (%)	N/A
			N/A	Flare Traversable LT?	N/A	N/A	Flare Traversable RT?	N/A
			N/A	Landing Length (in)	N/A	N/A	DWS Provided?	N/A
			N/A	Landing Width (in)	N/A	N/A	DWS Contrast?	N/A
			N/A	Landing Slope (%)	N/A	N/A	DWS Length (in)	N/A
			N/A	Landing X Slope (%)	N/A	N/A	DWS Full Width?	N/A
Surveyor Notes:			N/A	Landing Curb? (Y/N)	N/A	N/A	DWS Offset (in)	N/A
N/A			N/A	Shared Landing?	N/A			
PROW/ADA:			N/A	Gutter Ponding?	N/A	N/A	Gutter Slope (%)	N/A
R304.5.1, R304.5.3			N/A	Gutter Lip Ht (in)	N/A	N/A	Gutter X Slope (%)	N/A
