Access Compliance Report

Public Rights-of-Way

(Curb Ramps)

Intersection ID: 10038783	Main Street: STEELE_CREEK_RD	Cross Street: N/A	Location: NE
ADA ID: E37EBE2BE6F5	Ramp Type: Directional1	Initial Pass/Fail: Pass	Overall Compliance: No
Codes/Mitigation Info/Possible Solution		Field Measurements/Component Compliance	
Severity Score: 2.75

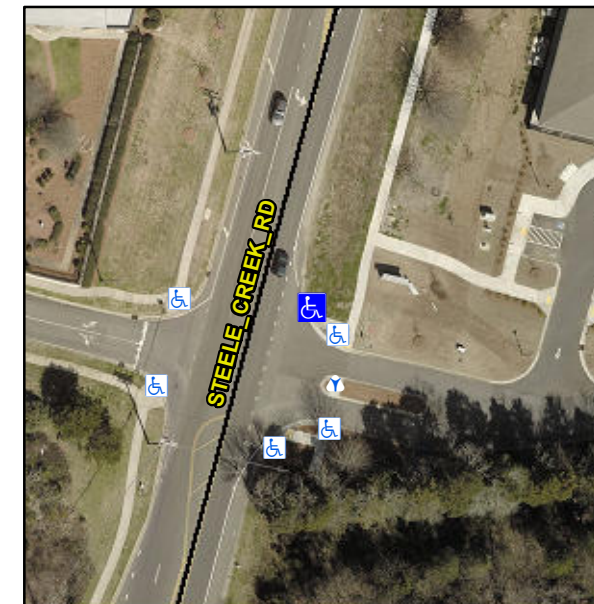
Compliance	Description	Data	Compliance	Description	Data
N/A	Ramp Length (in)	178.0	Yes	Grade Break?	Yes
Yes	Ramp Width (in)	59.0	Yes	Grade Break Slope (%)	1.3
Yes	Ramp Slope (%)	3.0	Yes	Grade Break XSlope (%)	0.4
No	Ramp XSlope (%)	2.2			
Yes	Flare Type LT	N/A	Yes	Flare Type RT	N/A
N/A	Flare Slope LT (%)	N/A	N/A	Flare Slope RT (%)	N/A
N/A	Flare Traversable LT?	No	N/A	Flare Traversable RT?	No
Yes	Landing Length (in)	60.0	Yes	DWS Provided?	Yes
Yes	Landing Width (in)	60.0	Yes	DWS Contrast?	Yes
Yes	Landing Slope (%)	1.2	Yes	DWS Length (in)	24.0
Yes	Landing X Slope (%)	2.0	No	DWS Full Width?	No
N/A	Landing Curb? (Y/N)	No	No	DWS Offset LT (in)	66.0
N/A	Shared Landing?	Yes	No	DWS Offset RT (in)	18.0
No	Gutter Ponding?	Yes	Yes	Gutter Slope (%)	0.8
Yes	Gutter Lip Ht (in)	0.0	Yes	Gutter X Slope (%)	0.8
N/A	Painted X Walk1?	No		Road Slope (%)	4.4
	X Walk 1 Direction	To W		Road X Slope (%)	2.0
	X Walk 1 Width (in)	N/A		Clear Space?	Yes

X Walk 1 Slope (%)	4.4	N/A	Clear Space to XWalk (in)	N/A
	X Walk 1 X Slope (%)	2.0	Yes	Storm Grate/Utility Hazard?	No
N/A	Ramp inside XWalk1?	N/A		Storm Grate/Utility Type	
Yes	Any Obstructions?	No			N/A
	Obstruction Type		Yes	Surface Condition? (G/P)	Good
			N/A	Curb Slope (%)	2.6

**Remove & Replace Entire Ramp.
Gutter Ponding Observed.**
