Access Compliance Report

Public Rights-of-Way

(Curb Ramps)

Intersection ID: 52610	Main Street: LEGRANGER_RD	Cross Street: HERITAGE_POND_DR	Location: NW
ADA ID: E384D792AF56	Ramp Type: Perp	Initial Pass/Fail: Fail	Overall Compliance: No
			Severity Score: 13.75

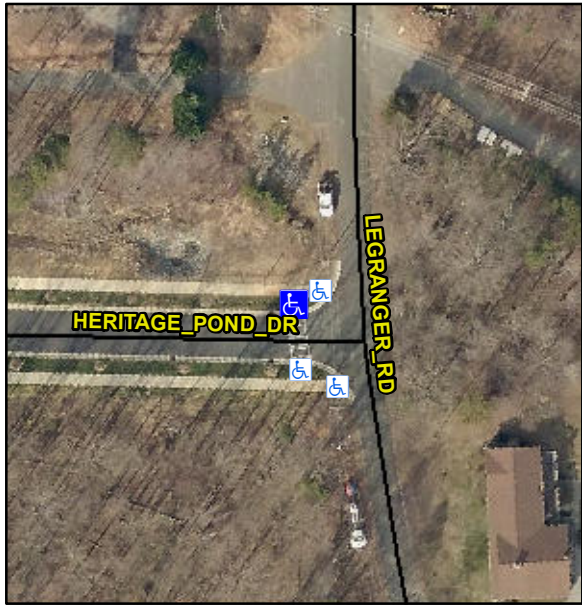
Possible Solutions:		Compliance	Description	Data	Compliance	Description	Data
	Remove & Replace Entire Ramp.		N/A	Ramp Length (in)	87.0	No	Ramp Slope (%)	11.2
			Yes	Ramp Width (in)	70.5	No	Ramp XSlope (%)	3.3
			N/A	Flare Type LT	N/A	N/A	Flare Type RT	N/A
			N/A	Flare Slope LT (%)	N/A	N/A	Flare Slope RT (%)	N/A
			N/A	Flare Traversable LT?	N/A	N/A	Flare Traversable RT?	N/A
			N/A	Landing Length (in)	N/A	N/A	DWS Provided?	N/A
			N/A	Landing Width (in)	N/A	N/A	DWS Contrast?	N/A
			N/A	Landing Slope (%)	N/A	N/A	DWS Length (in)	N/A
			N/A	Landing X Slope (%)	N/A	N/A	DWS Full Width?	N/A
Surveyor Notes:		N/A	N/A	Landing Curb? (Y/N)	N/A	N/A	DWS Offset (in)	N/A
PROW/ADA:		R304.2.2, R304.5.3	N/A	Shared Landing?	N/A			
			N/A	Gutter Ponding?	N/A	N/A	Gutter Slope (%)	N/A
			N/A	Gutter Lip Ht (in)	N/A	N/A	Gutter X Slope (%)	N/A

N/A	Painted X Walk1?	Yes	N/A	Painted X Walk2?	N/A
				X Walk 1 Direction	To S		X Walk 2 Direction	N/A
			N/A	X Walk 1 Width (in)	106.0	N/A	X Walk 2 Width (in)	N/A
				X Walk 1 Slope (%)	0.9		X Walk 2 Slope (%)	N/A
				X Walk 1 X Slope (%)	4.9		X Walk 2 X Slope (%)	N/A
			N/A	Ramp inside XWalk1?	Yes	N/A	Ramp inside XWalk2?	N/A
				Road Slope (%)	N/A	N/A	Clear Space?	N/A
				Road X Slope (%)	N/A	N/A	Clear Space to XWalk (in)	N/A
			N/A	Any Obstructions?	N/A	N/A	Storm Grate/Utility Hazard?	N/A
				Obstruction Type			Storm Grate/Utility Type	
					N/A			N/A
						Yes	Surface Condition? (G/P)	Good
						</
