Intersection ID: 28859	Main Street: WILDBROOK_DR	Cross Street: WREN_CREEK_DR	Location:	E
ADA ID: E38AC7278E44	Ramp Type: PerpDiag	Initial Pass/Fail: Fail	Overall Compliance: No	Severity Score: 8.75

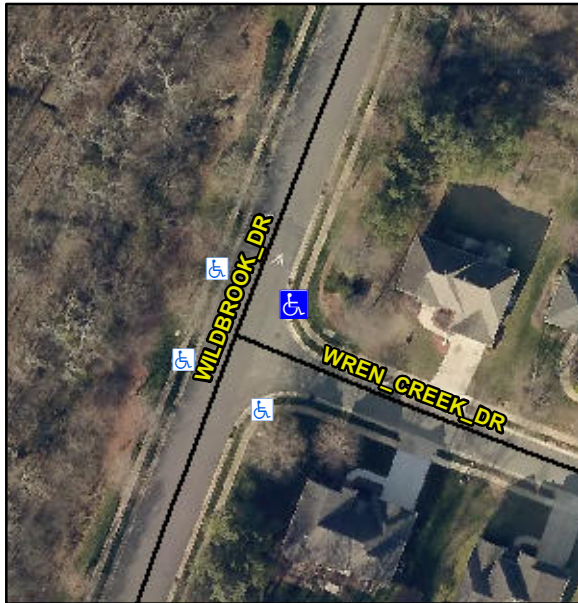
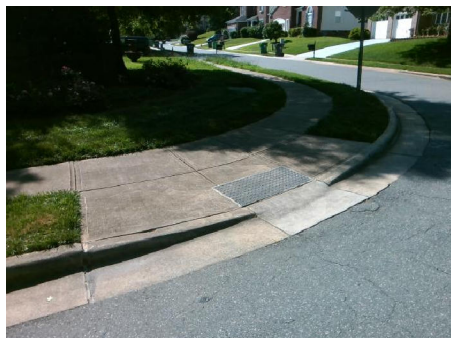
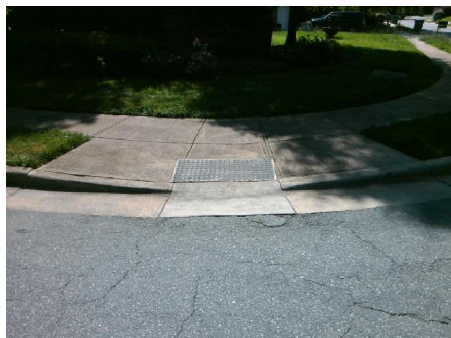
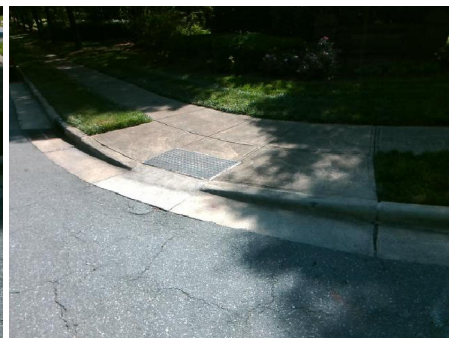
R304.5.1

Compliance	Description	Data	Compliance	Description	Data
N/A	Ramp Length (in)	47.0	Yes	Ramp Slope (%)	6.5
No	Ramp Width (in)	42.0	Yes	Ramp XSlope (%)	1.2
N/A	Flare Type LT	N/A	N/A	Flare Type RT	N/A
N/A	Flare Slope LT (%)	N/A	N/A	Flare Slope RT (%)	N/A
N/A	Flare Traversable LT?	N/A	N/A	Flare Traversable RT?	N/A
N/A	Landing Length (in)	N/A	N/A	DWS Provided?	N/A
N/A	Landing Width (in)	N/A	N/A	DWS Contrast?	N/A
N/A	Landing Slope (%)	N/A	N/A	DWS Length (in)	N/A
N/A	Landing X Slope (%)	N/A	N/A	DWS Full Width?	N/A
N/A	Landing Curb? (Y/N)	N/A	N/A	DWS Offset (in)	N/A
N/A	Shared Landing?	N/A			
N/A	Gutter Ponding?	N/A	N/A	Gutter Slope (%)	N/A
N/A	Gutter Lip Ht (in)	N/A	N/A	Gutter X Slope (%)	N/A
N/A	Painted X Walk1?	No	N/A	Painted X Walk2?	No
	X Walk 1 Direction	To NW		X Walk 2 Direction	To SW
N/A	X Walk 1 Width (in)	N/A	N/A	X Walk 2 Width (in)	N/A
	X Walk 1 Slope (%)	4.3		X Walk 2 Slope (%)	1.5
	X Walk 1 X Slope (%)	1.9		X Walk 2 X Slope (%)	0.6

N/A	Ramp inside XWalk1?	N/A	N/A	Ramp inside XWalk2?	N/A
	Road Slope (%)	3.1	N/A	Clear Space?	N/A
	Road X Slope (%)	1.9	N/A	Clear Space to XWalk (in)	N/A
N/A	Any Obstructions?	N/A	N/A	Storm Grate/Utility Hazard?	N/A
	Obstruction Type			Storm Grate/Utility Type	
		N/A			N/A
			Yes	Surface Condition? (G/P)	Good

Remove & Replace Curb Ramp With Two New Directional Ramps or Equivalent.
