Access Compliance Report

Public Rights-of-Way

(Curb Ramps)

Intersection ID: 5056	Main Street: HEDGECREST_PL	Cross Street: HUBBARD_RD	Location: NW
ADA ID: E38FC2C26BD6	Ramp Type: PerpDiag	Initial Pass/Fail: Fail	Overall Compliance: No
Severity Score: 25			
Codes/Mitigation Info/Possible Solution		Field Measurements/Component Compliance

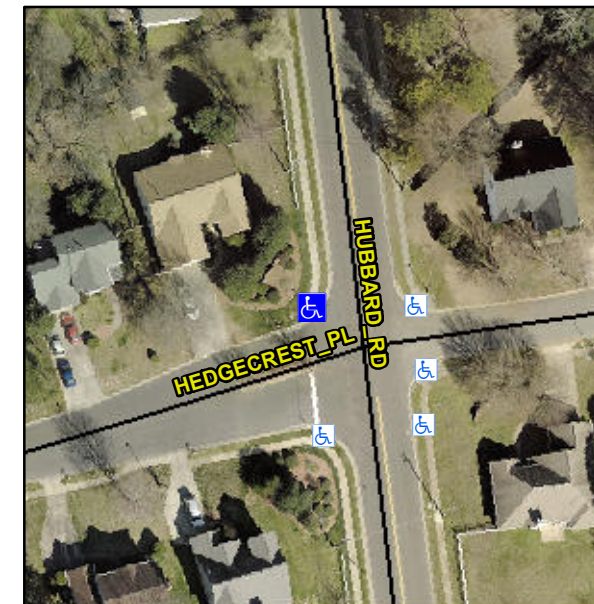
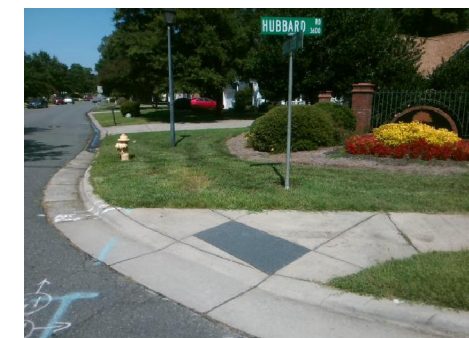
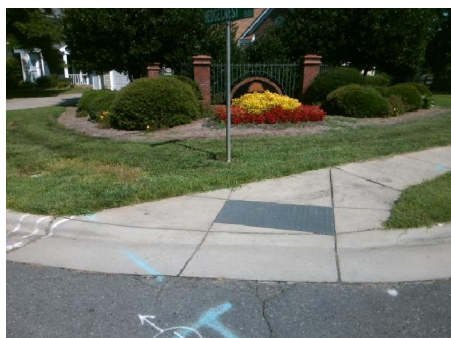
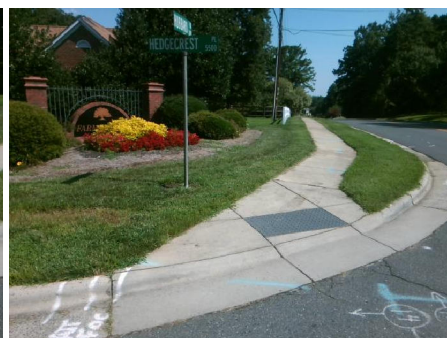
Not Found, R304.2.2

Compliance	Description	Data	Compliance	Description	Data
N/A	Ramp Length (in)	51.0	No	Ramp Slope (%)	15.6
Yes	Ramp Width (in)	48.0	Yes	Ramp XSlope (%)	1.4
N/A	Flare Type LT	N/A	N/A	Flare Type RT	N/A
N/A	Flare Slope LT (%)	N/A	N/A	Flare Slope RT (%)	N/A
N/A	Flare Traversable LT?	N/A	N/A	Flare Traversable RT?	N/A
N/A	Landing Length (in)	N/A	N/A	DWS Provided?	N/A
N/A	Landing Width (in)	N/A	N/A	DWS Contrast?	N/A
N/A	Landing Slope (%)	N/A	N/A	DWS Length (in)	N/A
N/A	Landing X Slope (%)	N/A	N/A	DWS Full Width?	N/A
N/A	Landing Curb? (Y/N)	N/A	N/A	DWS Offset (in)	N/A
N/A	Shared Landing?	N/A			
N/A	Gutter Ponding?	N/A	N/A	Gutter Slope (%)	N/A
N/A	Gutter Lip Ht (in)	N/A	N/A	Gutter X Slope (%)	N/A
N/A	Painted X Walk1?	No	N/A	Painted X Walk2?	No
	X Walk 1 Direction	To W		X Walk 2 Direction	To E
N/A	X Walk 1 Width (in)	N/A	N/A	X Walk 2 Width (in)	N/A
	X Walk 1 Slope (%)	0.9		X Walk 2 Slope (%)	4.4
	X Walk 1 X Slope (%)	3.6		X Walk 2 X Slope (%)	1.6

N/A	Ramp inside XWalk1?	N/A	N/A	Ramp inside XWalk2?	N/A
	Road Slope (%)	3.0	N/A	Clear Space?	N/A
	Road X Slope (%)	3.9	N/A	Clear Space to XWalk (in)	N/A
N/A	Any Obstructions?	N/A	N/A	Storm Grate/Utility Hazard?	N/A
	Obstruction Type			Storm Grate/Utility Type	
		N/A			N/A
		Yes		Surface Condition? (G/P)	Good

Remove & Replace Curb Ramp With Two New Directional Ramps or Equivalent.

Total Cost: \$ 3200.00
