# Access Compliance Report

## Public Rights-of-Way

| Intersection ID: 17609 | Main Street: E_WOODLAWN_RD | Cross Street: STERLING_DR | Location: NW |
| ADA ID: E393662E69CA | Ramp Type: BlendTrans2 | Initial Pass/Fail: Pass | Overall Compliance: No |

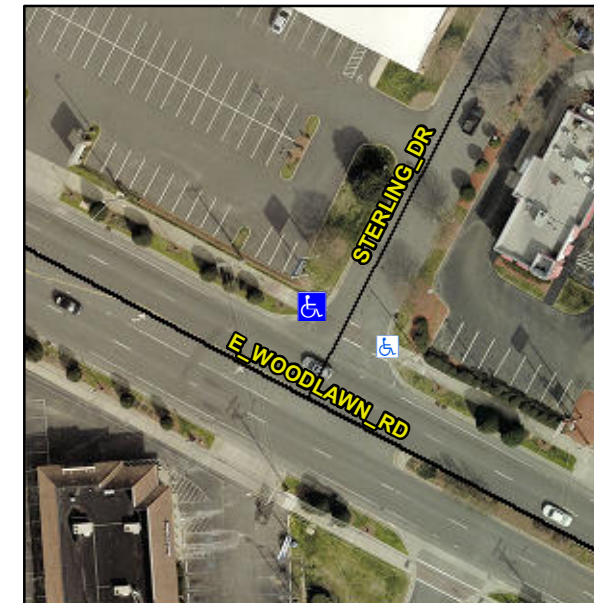
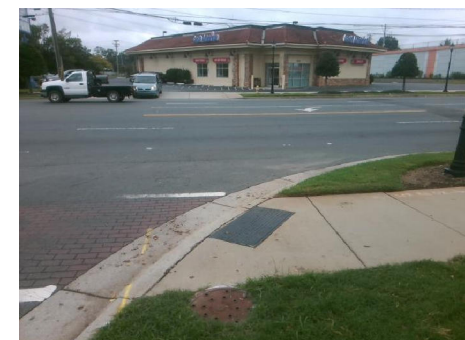
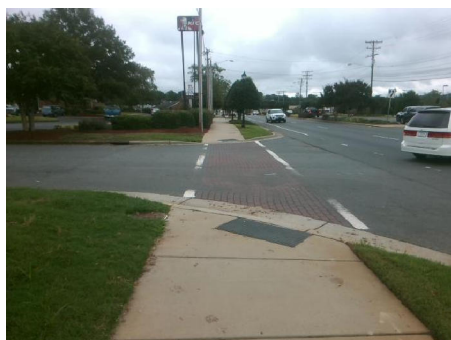
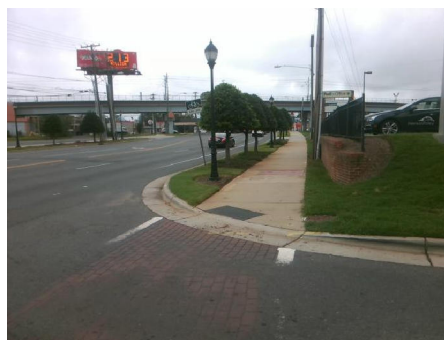
| Compliance | Description | Data | Compliance | Description | Data |
|---|---|---|---|---|---|
| N/A | Landing X Slope (%) | N/A | No | DWS Full Width? | No |
| Yes | Gutter Ponding? | No | No | Gutter Slope (%) | 5.4 |
| Yes | Gutter Lip Ht (in) | 0.0 | No | Gutter X Slope (%) | 2.9 |

**Remove & Replace Detectable Warning System. Remove & Replace Gutter.**

**R305.1.4, R304.5.4, R304.5.3**
