Access Compliance Report

Public Rights-of-Way

(Curb Ramps)

Intersection ID: N/A	Main Street: MCKEE_RD	Cross Street: N/A	Location: NE
ADA ID: E3A5DF74B0CA	Ramp Type: Perp	Initial Pass/Fail: Fail	Overall Compliance: No
Codes/Mitigation Info/Possible Solution		Field Measurements/Component Compliance	
Severity Score: 28.75

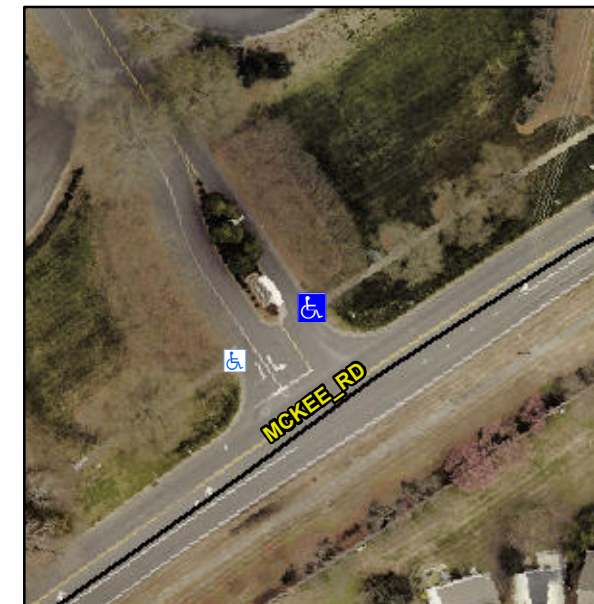
Not Found, R304.2.2, R304.5.3, R302.7

Compliance	Description	Data	Compliance	Description	Data
N/A	Ramp Length (in)	50.0	No	Ramp Slope (%)	8.5
Yes	Ramp Width (in)	48.0	No	Ramp XSlope (%)	2.9
N/A	Flare Type LT	N/A	N/A	Flare Type RT	N/A
N/A	Flare Slope LT (%)	N/A	N/A	Flare Slope RT (%)	N/A
N/A	Flare Traversable LT?	N/A	N/A	Flare Traversable RT?	N/A
N/A	Landing Length (in)	N/A	N/A	DWS Provided?	N/A
N/A	Landing Width (in)	N/A	N/A	DWS Contrast?	N/A
N/A	Landing Slope (%)	N/A	N/A	DWS Length (in)	N/A
N/A	Landing X Slope (%)	N/A	N/A	DWS Full Width?	N/A
N/A	Landing Curb? (Y/N)	N/A	N/A	DWS Offset (in)	N/A
N/A	Shared Landing?	N/A			
N/A	Gutter Ponding?	N/A	N/A	Gutter Slope (%)	N/A
N/A	Gutter Lip Ht (in)	N/A	N/A	Gutter X Slope (%)	N/A
N/A	Painted X Walk1?	No	N/A	Painted X Walk2?	N/A
	X Walk 1 Direction	To SW		X Walk 2 Direction	N/A
N/A	X Walk 1 Width (in)	N/A	N/A	X Walk 2 Width (in)	N/A
	X Walk 1 Slope (%)	1.9		X Walk 2 Slope (%)	N/A
	X Walk 1 X Slope (%)	3.5		X Walk 2 X Slope (%)	N/A

N/A	Ramp inside XWalk1?	N/A	N/A	Ramp inside XWalk2?	N/A
	Road Slope (%)	N/A	N/A	Clear Space?	N/A
	Road X Slope (%)	N/A	N/A	Clear Space to XWalk (in)	N/A
N/A	Any Obstructions?	N/A	N/A	Storm Grate/Utility Hazard?	N/A
	Obstruction Type			Storm Grate/Utility Type	
		N/A			N/A
		No		Surface Condition? (G/P)	Poor

Possible Solutions:

Remove & Replace Entire Ramp.

Total Cost: \$ 1850.00
