# Access Compliance Report

## Public Rights-of-Way

### (Curb Ramps)

Intersection ID: 25269	Main Street: REA_RD	Cross Street: SUMMER_GATE_DR	Location: SW
ADA ID: E3B6921DF84E	Ramp Type: Directional1	Initial Pass/Fail: Fail	Overall Compliance: No
		Severity Score: 1.25

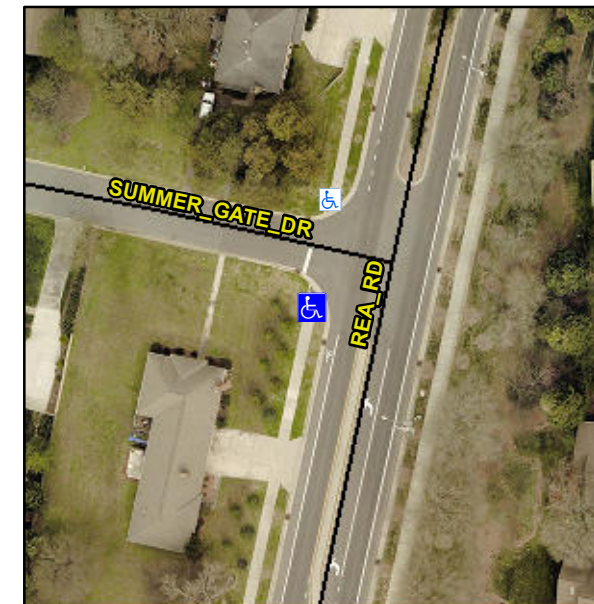
Compliance	Description	Data	Compliance	Description	Data
N/A	Ramp Length (in)	109.0	N/A	Grade Break?	N/A
Yes	Ramp Width (in)	71.0	N/A	Grade Break Slope (%)	0.0
Yes	Ramp Slope (%)	5.6	N/A	Grade Break XSlope (%)	0.0
No	Ramp XSlope (%)	3.4			
N/A	Flare Type LT	N/A	N/A	Flare Type RT	N/A
N/A	Flare Slope LT (%)	N/A	N/A	Flare Slope RT (%)	0.0
N/A	Flare Traversable LT?	N/A	N/A	Flare Traversable RT?	N/A
N/A	Landing Length (in)	0.0	N/A	DWS Provided?	N/A
N/A	Landing Width (in)	0.0	N/A	DWS Contrast?	N/A
N/A	Landing Slope (%)	0.0	N/A	DWS Length (in)	N/A
N/A	Landing X Slope (%)	0.0	N/A	DWS Full Width?	N/A
N/A	Landing Curb? (Y/N)	N/A	N/A	DWS Offset LT (in)	N/A
N/A	Shared Landing?	N/A	N/A	DWS Offset RT (in)	N/A
N/A	Gutter Ponding?	0.0	N/A	Gutter Slope (%)	N/A
N/A	Gutter Lip Ht (in)	0.0	N/A	Gutter X Slope (%)	N/A
N/A	Painted X Walk1?	No		Road Slope (%)	1.7
	X Walk 1 Direction	To N		Road X Slope (%)	1.4
	X Walk 1 Width (in)	N/A		Clear Space?	N/A

X Walk 1 Slope (%)	1.7	N/A	Clear Space to XWalk (in)	N/A
	X Walk 1 X Slope (%)	1.4	N/A	Storm Grate/Utility Hazard?	N/A
N/A	Ramp inside XWalk1?	N/A		Storm Grate/Utility Type	
N/A	Any Obstructions?	N/A			N/A
	Obstruction Type		Yes	Surface Condition? (G/P)	Good
			N/A	Curb Slope (%)	5.8

Possible Solutions:

**Remove & Replace Entire Ramp.**

PROW/ADA:

**R304.5.3**
