Access Compliance Report

Public Rights-of-Way

(Curb Ramps)

Intersection ID: 4886	Main Street: OLD_STATESVILLE_RD	Cross Street: OAK_DR	Location:	E
ADA ID: E3C27C1D403E	Ramp Type: Perp	Initial Pass/Fail: Fail	Overall Compliance: No	Severity Score: 10
Codes/Mitigation Info/Possible Solution		Field Measurements/Component Compliance

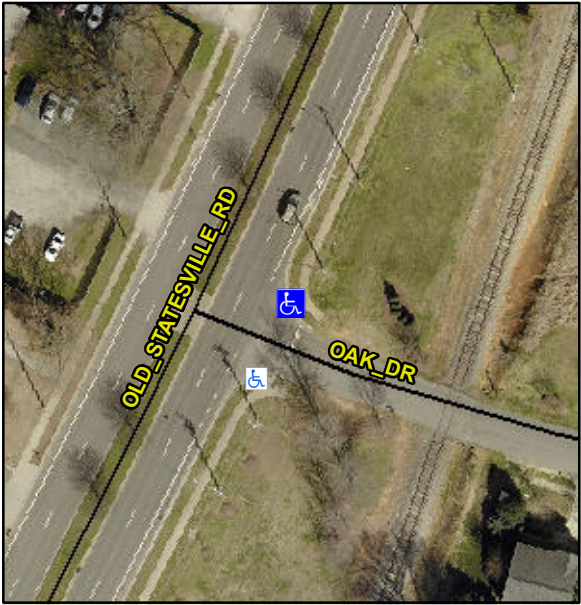
Possible Solutions:						
	Remove & Replace Entire Ramp.	N/A	Ramp Length (in)	60.0	Yes	Ramp Slope (%)	8.2
		No	Ramp Width (in)	36.0	No	Ramp XSlope (%)	2.5
		N/A	Flare Type LT	N/A	N/A	Flare Type RT	N/A
		N/A	Flare Slope LT (%)	N/A	N/A	Flare Slope RT (%)	N/A
		N/A	Flare Traversable LT?	N/A	N/A	Flare Traversable RT?	N/A
		N/A	Landing Length (in)	N/A	N/A	DWS Provided?	N/A
		N/A	Landing Width (in)	N/A	N/A	DWS Contrast?	N/A
		N/A	Landing Slope (%)	N/A	N/A	DWS Length (in)	N/A
		N/A	Landing X Slope (%)	N/A	N/A	DWS Full Width?	N/A
		N/A	Landing Curb? (Y/N)	N/A	N/A	DWS Offset (in)	N/A
		N/A	Shared Landing?	N/A			
		N/A	Gutter Ponding?	N/A	N/A	Gutter Slope (%)	N/A
		N/A	Gutter Lip Ht (in)	N/A	N/A	Gutter X Slope (%)	N/A
		N/A	Painted X Walk1?	No	N/A	Painted X Walk2?	N/A
			X Walk 1 Direction	To SW		X Walk 2 Direction	N/A
		N/A	X Walk 1 Width (in)	N/A	N/A	X Walk 2 Width (in)	N/A
			X Walk 1 Slope (%)	1.0		X Walk 2 Slope (%)	N/A

X Walk 1 X Slope (%)	1.1		X Walk 2 X Slope (%)	N/A
		N/A	Ramp inside XWalk1?	N/A	N/A	Ramp inside XWalk2?	N/A
<p>Surveyor Notes:</p> <p>N/A</p> <p>PROW/ADA:</p> <p>Not Found, R304.5.1, R304.5.3</p>		N/A	Road Slope (%)	N/A	N/A	Clear Space?	N/A
		N/A	Road X Slope (%)	N/A	N/A	Clear Space to XWalk (in)	N/A
		N/A	Any Obstructions?	N/A	N/A	Storm Grate/Utility Hazard?	N/A
			Obstruction Type			Storm Grate/Utility Type	
					N/A		N/A
					Yes	Surface Condition? (G/P)	Good
Total Cost:		\$	1850.00
