# Access Compliance Report

## Public Rights-of-Way

### (Curb Ramps)

| Intersection ID: 12482 | Main Street: SEAFORTH_DR | Cross Street: SUDBURY_RD | Location: SW |

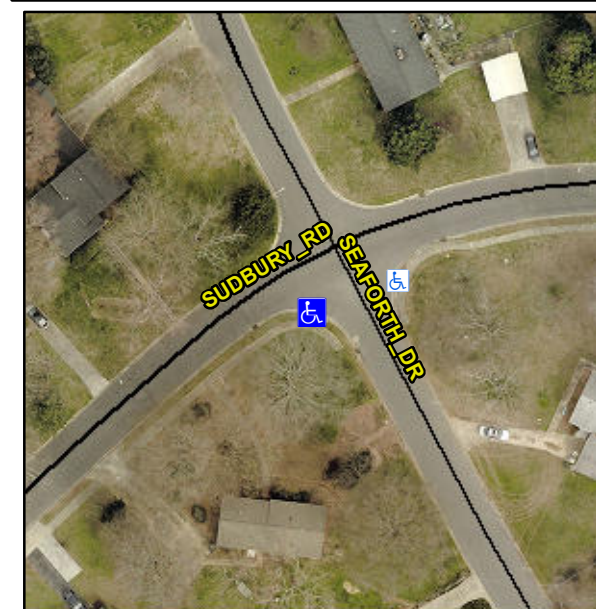
| ADA ID: E3CA4607CD08 | Ramp Type: BlendTrans1 | Initial Pass/Fail: Fail | Overall Compliance: No |
| Severity Score: 17.5 | | | |

**Not Found, R304.5.1**

| Compliance | Description | Data | Compliance | Description | Data |
|---|---|---|---|---|---|
| No | Ramp Width (in) | 34.0 | Yes | BlendTrans XSlope (%) | 0.3 |
| | | | No | Curb Slope (%) | 14.6 |

**Remove & Replace Curb Ramp With Two New Directional Ramps or Equivalent.**

Total Cost: \$ 3200.00
