Access Compliance Report

Public Rights-of-Way

(Curb Ramps)

Intersection ID: 8329	Main Street: BEATTIES_FORD_RD	Cross Street: LASALLE_ST	Location: NW
ADA ID: E3D383120F66	Ramp Type: Perp	Initial Pass/Fail: Pass	Overall Compliance: No
Codes/Mitigation Info/Possible Solution			Severity Score: 0
			Field Measurements/Component Compliance

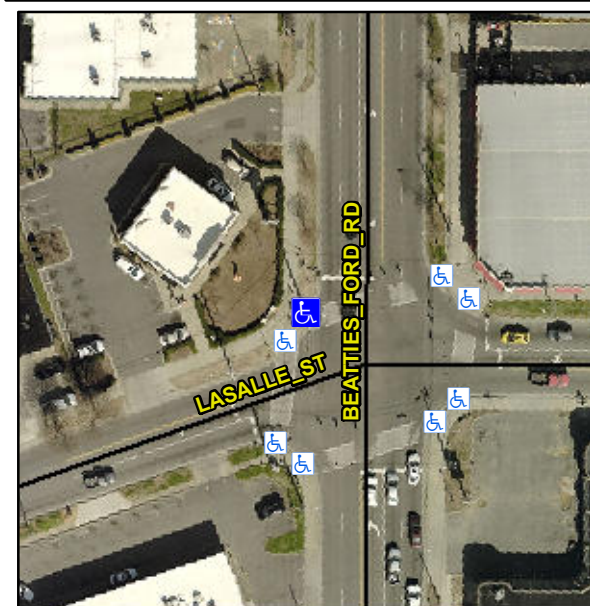
Compliance	Description	Data	Compliance	Description	Data
N/A	Ramp Length (in)	82.5	Yes	Ramp Slope (%)	7.1
Yes	Ramp Width (in)	48.0	Yes	Ramp XSlope (%)	0.1
N/A	Flare Type LT	Sloped	N/A	Flare Type RT	N/A
N/A	Flare Slope LT (%)	4.9	Yes	Flare Slope RT (%)	4.7
N/A	Flare Traversable LT?	Yes	N/A	Flare Traversable RT?	Yes
Yes	Landing Length (in)	118.0	Yes	DWS Provided?	Yes
Yes	Landing Width (in)	48.0	Yes	DWS Contrast?	Yes
Yes	Landing Slope (%)	1.0	Yes	DWS Length (in)	24.0
Yes	Landing X Slope (%)	0.5	Yes	DWS Full Width?	Yes
N/A	Landing Curb? (Y/N)	No	Yes	DWS Offset (in)	0.0
N/A	Shared Landing?	No			
Yes	Gutter Ponding?	No	Yes	Gutter Slope (%)	1.6
Yes	Gutter Lip Ht (in)	0.0	Yes	Gutter X Slope (%)	0.6
N/A	Painted X Walk1?	Yes	N/A	Painted X Walk2?	N/A
	X Walk 1 Direction	To NE		X Walk 2 Direction	N/A
N/A	X Walk 1 Width (in)	120.5	N/A	X Walk 2 Width (in)	N/A
	X Walk 1 Slope (%)	2.7		X Walk 2 Slope (%)	N/A
	X Walk 1 X Slope (%)	0.2		X Walk 2 X Slope (%)	N/A

Yes	Ramp inside XWalk1?	Yes	N/A	Ramp inside XWalk2?	N/A
	Road Slope (%)	N/A	N/A	Clear Space?	Yes
	Road X Slope (%)	N/A	N/A	Clear Space to XWalk (in)	N/A
Yes	Any Obstructions?	No	Yes	Storm Grate/Utility Hazard?	No
	Obstruction Type			Storm Grate/Utility Type	
			N/A		N/A
			Yes	Surface Condition? (G/P)	Good

Possible Solutions:

Remove & Replace Entire Ramp.
