Access Compliance Report

Public Rights-of-Way

(Curb Ramps)

Intersection ID: 6526	Main Street: CENTURY_OAKS_LN	Cross Street: MINERAL_SPRINGS_RD	Location: NE
ADA ID: E3D5910567F9	Ramp Type: PerpDiag	Initial Pass/Fail: Fail	Overall Compliance: No
Severity Score: 21.25			
Codes/Mitigation Info/Possible Solution		Field Measurements/Component Compliance

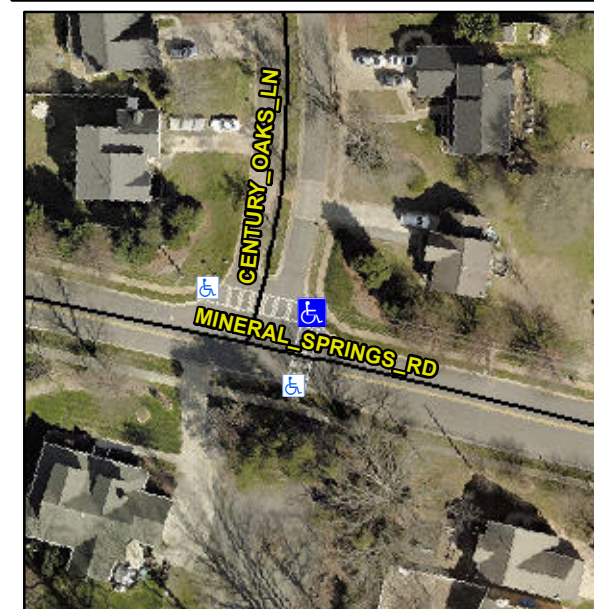
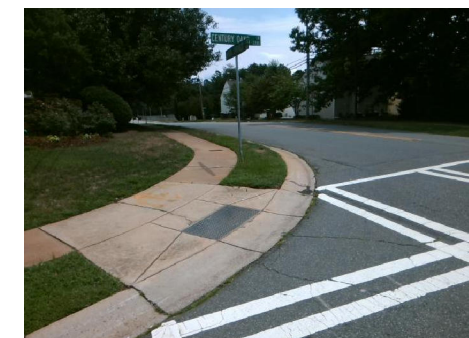
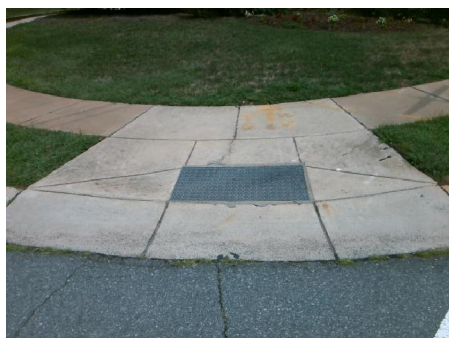
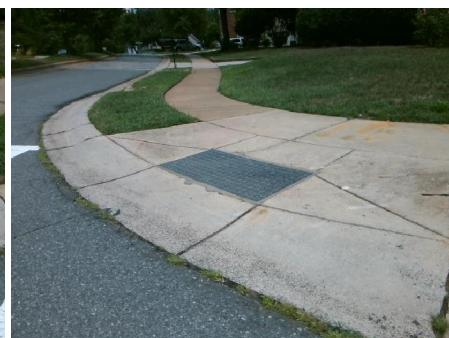
Not Found, R304.5.1, R304.5.3

Compliance	Description	Data	Compliance	Description	Data
N/A	Ramp Length (in)	48.0	Yes	Ramp Slope (%)	7.3
No	Ramp Width (in)	43.0	No	Ramp XSlope (%)	5.6
N/A	Flare Type LT	N/A	N/A	Flare Type RT	N/A
N/A	Flare Slope LT (%)	N/A	N/A	Flare Slope RT (%)	N/A
N/A	Flare Traversable LT?	N/A	N/A	Flare Traversable RT?	N/A
N/A	Landing Length (in)	N/A	N/A	DWS Provided?	N/A
N/A	Landing Width (in)	N/A	N/A	DWS Contrast?	N/A
N/A	Landing Slope (%)	N/A	N/A	DWS Length (in)	N/A
N/A	Landing X Slope (%)	N/A	N/A	DWS Full Width?	N/A
N/A	Landing Curb? (Y/N)	N/A	N/A	DWS Offset (in)	N/A
N/A	Shared Landing?	N/A			
N/A	Gutter Ponding?	N/A	N/A	Gutter Slope (%)	N/A
N/A	Gutter Lip Ht (in)	N/A	N/A	Gutter X Slope (%)	N/A
N/A	Painted X Walk1?	Yes	N/A	Painted X Walk2?	Yes
	X Walk 1 Direction	To W		X Walk 2 Direction	To S
N/A	X Walk 1 Width (in)	112.5	N/A	X Walk 2 Width (in)	112.5
	X Walk 1 Slope (%)	0.6		X Walk 2 Slope (%)	6.1
	X Walk 1 X Slope (%)	5.3		X Walk 2 X Slope (%)	1.4

N/A	Ramp inside XWalk1?	Yes	N/A	Ramp inside XWalk2?	Yes
	Road Slope (%)	4.5	N/A	Clear Space?	N/A
	Road X Slope (%)	4.4	N/A	Clear Space to XWalk (in)	N/A
N/A	Any Obstructions?	N/A	N/A	Storm Grate/Utility Hazard?	N/A
	Obstruction Type			Storm Grate/Utility Type	
		N/A			N/A
		Yes		Surface Condition? (G/P)	Good

Remove & Replace Curb Ramp With Two New Directional Ramps or Equivalent.
