Access Compliance Report

Public Rights-of-Way

(Curb Ramps)

Intersection ID: 43648	Main Street: CAMDEN_MEADOW_DR	Cross Street: SWANN_BRANCH_DR	Location: SW
ADA ID: E3DCBCD7D2C9	Ramp Type: PerpDiag	Initial Pass/Fail: Fail	Overall Compliance: No
Severity Score: 10			
Codes/Mitigation Info/Possible Solution		Field Measurements/Component Compliance

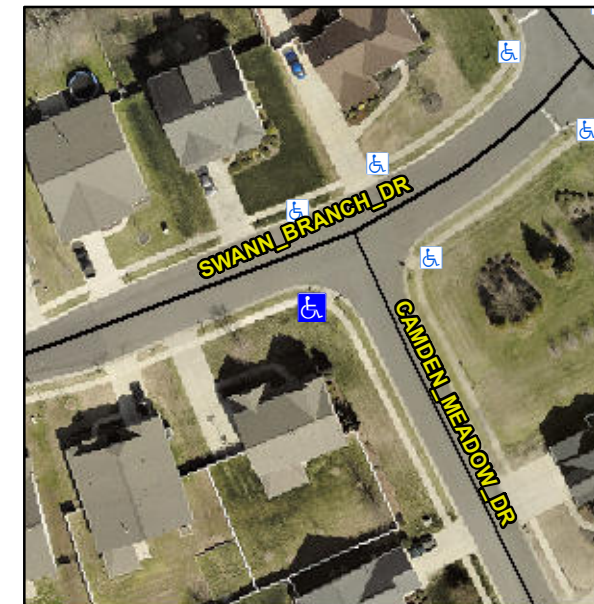
Not Found, R304.5.1, R304.5.3

Compliance	Description	Data	Compliance	Description	Data
N/A	Ramp Length (in)	47.5	Yes	Ramp Slope (%)	6.9
No	Ramp Width (in)	46.0	No	Ramp XSlope (%)	2.3
N/A	Flare Type LT	N/A	N/A	Flare Type RT	N/A
N/A	Flare Slope LT (%)	N/A	N/A	Flare Slope RT (%)	N/A
N/A	Flare Traversable LT?	N/A	N/A	Flare Traversable RT?	N/A
N/A	Landing Length (in)	N/A	N/A	DWS Provided?	N/A
N/A	Landing Width (in)	N/A	N/A	DWS Contrast?	N/A
N/A	Landing Slope (%)	N/A	N/A	DWS Length (in)	N/A
N/A	Landing X Slope (%)	N/A	N/A	DWS Full Width?	N/A
N/A	Landing Curb? (Y/N)	N/A	N/A	DWS Offset (in)	N/A
N/A	Shared Landing?	N/A			
N/A	Gutter Ponding?	N/A	N/A	Gutter Slope (%)	N/A
N/A	Gutter Lip Ht (in)	N/A	N/A	Gutter X Slope (%)	N/A
N/A	Painted X Walk1?	No	N/A	Painted X Walk2?	No
	X Walk 1 Direction	To E		X Walk 2 Direction	To N
N/A	X Walk 1 Width (in)	N/A	N/A	X Walk 2 Width (in)	N/A
	X Walk 1 Slope (%)	2.6		X Walk 2 Slope (%)	3.9
	X Walk 1 X Slope (%)	1.3		X Walk 2 X Slope (%)	1.8

N/A	Ramp inside XWalk1?	N/A	N/A	Ramp inside XWalk2?	N/A
	Road Slope (%)	1.5	N/A	Clear Space?	N/A
	Road X Slope (%)	3.6	N/A	Clear Space to XWalk (in)	N/A
N/A	Any Obstructions?	N/A	N/A	Storm Grate/Utility Hazard?	N/A
	Obstruction Type			Storm Grate/Utility Type	
		N/A			N/A
			Yes	Surface Condition? (G/P)	Good

Remove & Replace Curb Ramp With Two New Directional Ramps or Equivalent.
