Access Compliance Report

Public Rights-of-Way

(Curb Ramps)

Intersection ID: N/A	Main Street: S_DAVIDSON_ST	Cross Street: N/A	Location: W
ADA ID: E3DDAD8A8C6F	Ramp Type: Perp	Initial Pass/Fail: Fail	Overall Compliance: No
		Severity Score: 25

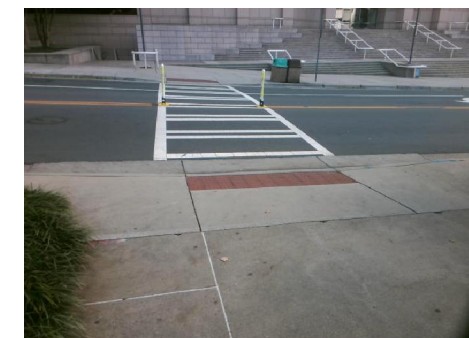
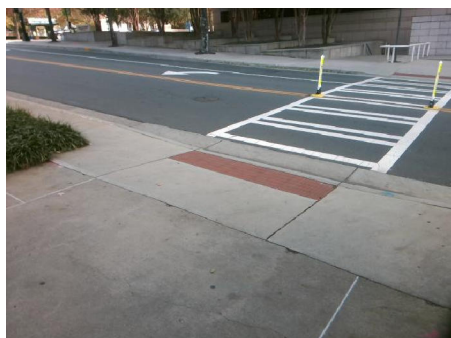
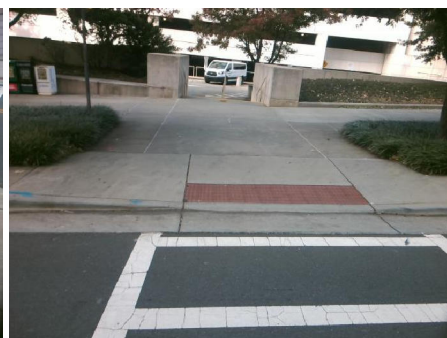
Not Found, R304.2.2, R304.5.3

Compliance	Description	Data	Compliance	Description	Data
N/A	Ramp Length (in)	71.5	No	Ramp Slope (%)	10.7
Yes	Ramp Width (in)	96.0	No	Ramp XSlope (%)	5.5
N/A	Flare Type LT	N/A	N/A	Flare Type RT	N/A
N/A	Flare Slope LT (%)	N/A	N/A	Flare Slope RT (%)	N/A
N/A	Flare Traversable LT?	No	N/A	Flare Traversable RT?	No
N/A	Landing Length (in)	N/A	N/A	DWS Provided?	N/A
N/A	Landing Width (in)	N/A	N/A	DWS Contrast?	N/A
N/A	Landing Slope (%)	N/A	N/A	DWS Length (in)	N/A
N/A	Landing X Slope (%)	N/A	N/A	DWS Full Width?	N/A
N/A	Landing Curb? (Y/N)	N/A	N/A	DWS Offset (in)	N/A
N/A	Shared Landing?	N/A			
N/A	Gutter Ponding?	N/A	N/A	Gutter Slope (%)	N/A
N/A	Gutter Lip Ht (in)	N/A	N/A	Gutter X Slope (%)	N/A
N/A	Painted X Walk1?	Yes	N/A	Painted X Walk2?	N/A
	X Walk 1 Direction	To SE		X Walk 2 Direction	N/A
N/A	X Walk 1 Width (in)	111.0	N/A	X Walk 2 Width (in)	N/A
	X Walk 1 Slope (%)	3.3		X Walk 2 Slope (%)	N/A
	X Walk 1 X Slope (%)	5.8		X Walk 2 X Slope (%)	N/A

N/A	Ramp inside XWalk1?	Yes	N/A	Ramp inside XWalk2?	N/A
	Road Slope (%)	N/A	N/A	Clear Space?	N/A
	Road X Slope (%)	N/A	N/A	Clear Space to XWalk (in)	N/A
N/A	Any Obstructions?	N/A	N/A	Storm Grate/Utility Hazard?	N/A
	Obstruction Type			Storm Grate/Utility Type	
		N/A			N/A
			Yes	Surface Condition? (G/P)	Good

Remove & Replace Entire Ramp.

Total Cost: \$ 1850.00
