# Access Compliance Report

## Public Rights-of-Way

### (Curb Ramps)

| Intersection ID: 21096 | Main Street: FOLGER_DR | Cross Street: OWENBY_CT | Location: | N |

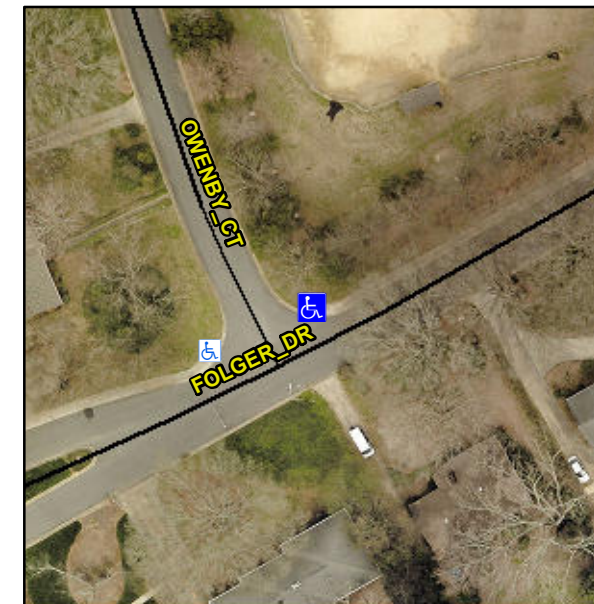
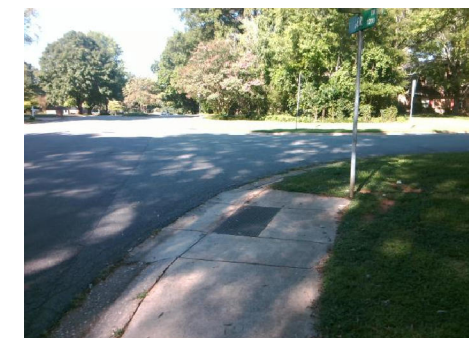
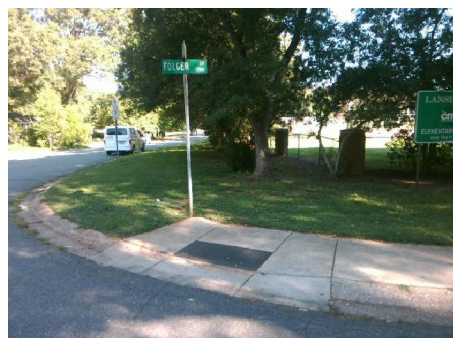
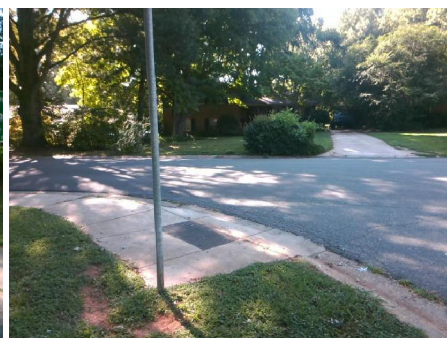
| ADA ID: E3E4B37919F4 | Ramp Type: ParaDiag | Initial Pass/Fail: Pass | Overall Compliance: No | Severity Score: 5.25 |

| Compliance | Description | Data | Compliance | Description | Data |
|---|---|---|---|---|---|
| Yes | Ramp XSlope LT (%) | 1.8 | No | Ramp XSlope RT (%) | 2.8 |
| No | Landing Slope (%) | 3.3 | Yes | DWS Length (in) | 25.0 |
| Yes | Gutter Ponding? | No | No | Gutter Slope (%) | 7.1 |

**Remove & Replace Curb Ramp With Two New Directional Ramps or Equivalent. Remove & Replace Gutter.**

**R304.5.3, R304.2.2-Perp, R304.3.2-Para, R304.5.4**

Total Cost: \$ 3950.00
