Access Compliance Report

Public Rights-of-Way

(Curb Ramps)

Intersection ID: 16681	Main Street: ELM_TREE_LN	Cross Street: WALNUT_WOOD_DR	Location: SE
ADA ID: E3E9BF1ADF4E	Ramp Type: Directional1	Initial Pass/Fail: Fail	Overall Compliance: No
		Severity Score: 12.5

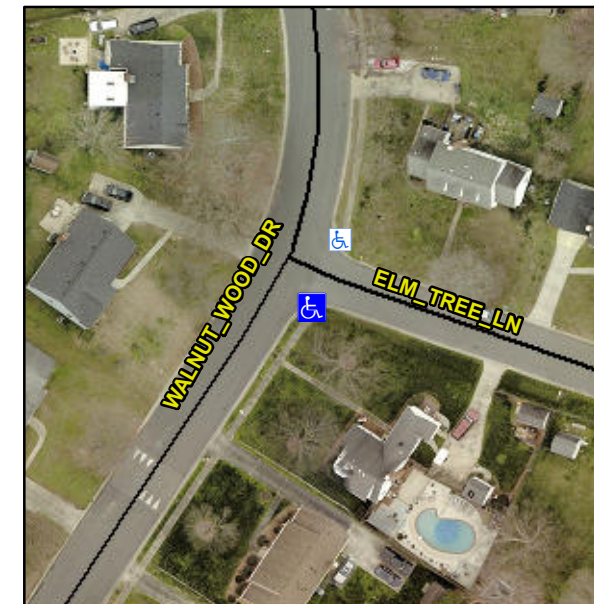
Compliance	Description	Data	Compliance	Description	Data
N/A	Ramp Length (in)	70.0	N/A	Grade Break?	N/A
Yes	Ramp Width (in)	48.0	N/A	Grade Break Slope (%)	0.0
Yes	Ramp Slope (%)	5.6	N/A	Grade Break XSlope (%)	0.0
No	Ramp XSlope (%)	5.1			
N/A	Flare Type LT	N/A	N/A	Flare Type RT	N/A
N/A	Flare Slope LT (%)	N/A	N/A	Flare Slope RT (%)	0.0
N/A	Flare Traversable LT?	N/A	N/A	Flare Traversable RT?	N/A
N/A	Landing Length (in)	0.0	N/A	DWS Provided?	N/A
N/A	Landing Width (in)	0.0	N/A	DWS Contrast?	N/A
N/A	Landing Slope (%)	0.0	N/A	DWS Length (in)	N/A
N/A	Landing X Slope (%)	0.0	N/A	DWS Full Width?	N/A
N/A	Landing Curb? (Y/N)	N/A	N/A	DWS Offset LT (in)	N/A
N/A	Shared Landing?	N/A	N/A	DWS Offset RT (in)	N/A
N/A	Gutter Ponding?	0.0	N/A	Gutter Slope (%)	N/A
N/A	Gutter Lip Ht (in)	0.0	N/A	Gutter X Slope (%)	N/A
N/A	Painted X Walk1?	No		Road Slope (%)	2.3
	X Walk 1 Direction	To N		Road X Slope (%)	2.0
	X Walk 1 Width (in)	N/A		Clear Space?	N/A

X Walk 1 Slope (%)	2.3	N/A	Clear Space to XWalk (in)	N/A
	X Walk 1 X Slope (%)	2.0	N/A	Storm Grate/Utility Hazard?	N/A
N/A	Ramp inside XWalk1?	N/A		Storm Grate/Utility Type	
N/A	Any Obstructions?	N/A			N/A
	Obstruction Type		Yes	Surface Condition? (G/P)	Good
			N/A	Curb Slope (%)	6.3

Possible Solutions:

Remove & Replace Entire Ramp.
