# Access Compliance Report

## Public Rights-of-Way

Intersection ID: 18583	Main Street: BURTONWOOD_CR	Cross Street: MONROE_RD	Location: NE
ADA ID: E3EB7BD02304	Ramp Type: PerpDiag	Initial Pass/Fail: Fail	Overall Compliance: No
		Severity Score: 25

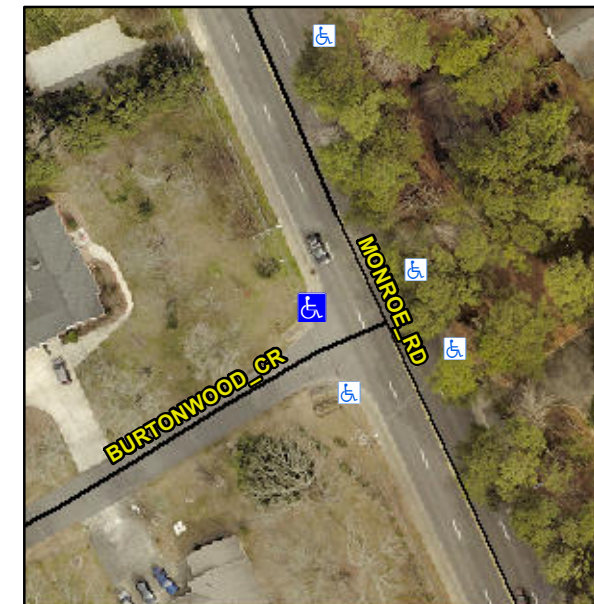
**Not Found, R304.2.2, R304.5.3**

Compliance	Description	Data	Compliance	Description	Data
N/A	Ramp Length (in)	60.0	No	Ramp Slope (%)	9.0
Yes	Ramp Width (in)	48.0	No	Ramp XSlope (%)	5.6
N/A	Flare Type LT	N/A	N/A	Flare Type RT	N/A
N/A	Flare Slope LT (%)	N/A	N/A	Flare Slope RT (%)	N/A
N/A	Flare Traversable LT?	N/A	N/A	Flare Traversable RT?	N/A
N/A	Landing Length (in)	N/A	N/A	DWS Provided?	N/A
N/A	Landing Width (in)	N/A	N/A	DWS Contrast?	N/A
N/A	Landing Slope (%)	N/A	N/A	DWS Length (in)	N/A
N/A	Landing X Slope (%)	N/A	N/A	DWS Full Width?	N/A
N/A	Landing Curb? (Y/N)	N/A	N/A	DWS Offset (in)	N/A
N/A	Shared Landing?	N/A			
N/A	Gutter Ponding?	N/A	N/A	Gutter Slope (%)	N/A
N/A	Gutter Lip Ht (in)	N/A	N/A	Gutter X Slope (%)	N/A
N/A	Painted X Walk1?	No	N/A	Painted X Walk2?	No
	X Walk 1 Direction	To S		X Walk 2 Direction	To W
N/A	X Walk 1 Width (in)	N/A	N/A	X Walk 2 Width (in)	N/A
	X Walk 1 Slope (%)	2.2		X Walk 2 Slope (%)	4.2
	X Walk 1 X Slope (%)	4.3		X Walk 2 X Slope (%)	0.6

N/A	Ramp inside XWalk1?	N/A	N/A	Ramp inside XWalk2?	N/A
	Road Slope (%)	3.5	N/A	Clear Space?	N/A
	Road X Slope (%)	4.5	N/A	Clear Space to XWalk (in)	N/A
N/A	Any Obstructions?	N/A	N/A	Storm Grate/Utility Hazard?	N/A
	Obstruction Type			Storm Grate/Utility Type	
		N/A			N/A
		Yes		Surface Condition? (G/P)	Good

**Remove & Replace Curb Ramp With Two New Directional Ramps or Equivalent.**

Total Cost: \$ 3200.00
