Access Compliance Report

Public Rights-of-Way

(Curb Ramps)

Intersection ID: 50927	Main Street: LANDING_PLACE_LN	Cross Street: LANCASTER_HY	Location: SW
ADA ID: E3F01862B46D	Ramp Type: PerpDiag	Initial Pass/Fail: Fail	Overall Compliance: No
Severity Score: 12.5			
Codes/Mitigation Info/Possible Solution		Field Measurements/Component Compliance

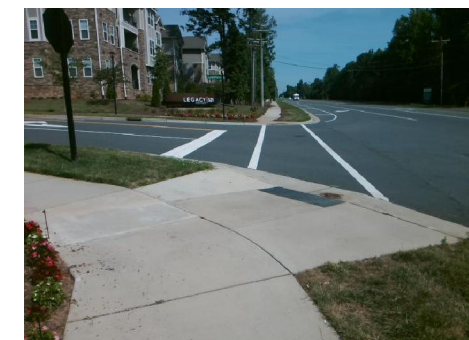
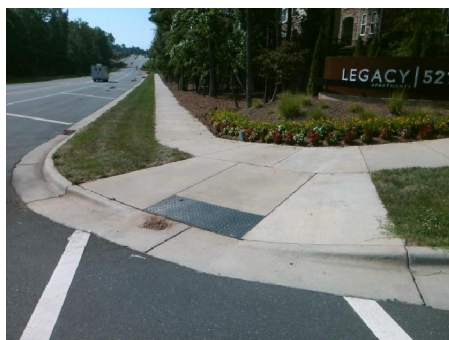
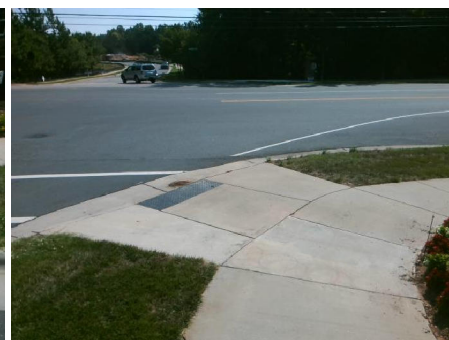
Compliance	Description	Data	Compliance	Description	Data
N/A	Ramp Length (in)	96.0	Yes	Ramp Slope (%)	5.2
Yes	Ramp Width (in)	60.0	No	Ramp XSlope (%)	5.3
N/A	Flare Type LT	N/A	N/A	Flare Type RT	N/A
N/A	Flare Slope LT (%)	N/A	N/A	Flare Slope RT (%)	N/A
N/A	Flare Traversable LT?	N/A	N/A	Flare Traversable RT?	N/A
N/A	Landing Length (in)	N/A	N/A	DWS Provided?	N/A
N/A	Landing Width (in)	N/A	N/A	DWS Contrast?	N/A
N/A	Landing Slope (%)	N/A	N/A	DWS Length (in)	N/A
N/A	Landing X Slope (%)	N/A	N/A	DWS Full Width?	N/A
N/A	Landing Curb? (Y/N)	N/A	N/A	DWS Offset (in)	N/A
N/A	Shared Landing?	N/A			
N/A	Gutter Ponding?	N/A	N/A	Gutter Slope (%)	N/A
N/A	Gutter Lip Ht (in)	N/A	N/A	Gutter X Slope (%)	N/A
N/A	Painted X Walk1?	No	N/A	Painted X Walk2?	Yes
	X Walk 1 Direction	To NE		X Walk 2 Direction	To NW
N/A	X Walk 1 Width (in)	N/A	N/A	X Walk 2 Width (in)	87.0
	X Walk 1 Slope (%)	3.0		X Walk 2 Slope (%)	1.1
	X Walk 1 X Slope (%)	4.8		X Walk 2 X Slope (%)	6.4

N/A	Ramp inside XWalk1?	N/A	N/A	Ramp inside XWalk2?	Yes
	Road Slope (%)	6.6	N/A	Clear Space?	N/A
	Road X Slope (%)	0.8	N/A	Clear Space to XWalk (in)	N/A
N/A	Any Obstructions?	N/A	N/A	Storm Grate/Utility Hazard?	N/A
	Obstruction Type			Storm Grate/Utility Type	
		N/A			N/A
			Yes	Surface Condition? (G/P)	Good

Remove & Replace Curb Ramp With Two New Directional Ramps or Equivalent.
