Access Compliance Report

Public Rights-of-Way

(Curb Ramps)

Intersection ID: 19935	Main Street: MORRISON_BV	Cross Street: ADAIR_CT	Location: SE
ADA ID: E3F0799A7E47	Ramp Type: Perp	Initial Pass/Fail: Fail	Overall Compliance: No
Severity Score: 13.75			
Codes/Mitigation Info/Possible Solution		Field Measurements/Component Compliance

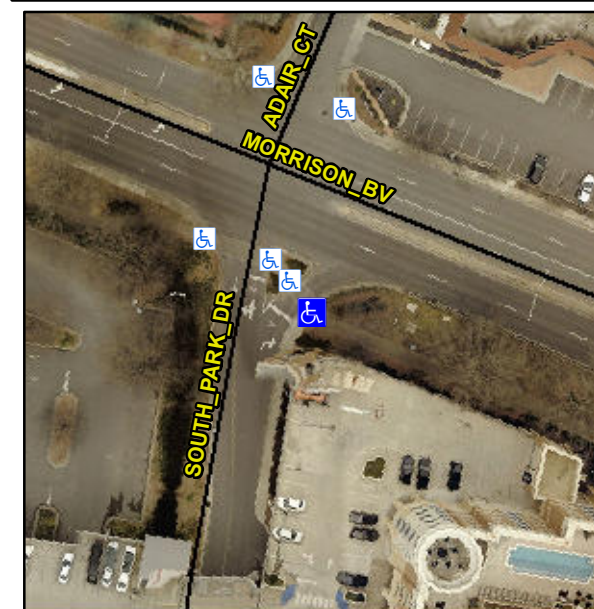
R304.2.2, R304.5.3

Compliance	Description	Data	Compliance	Description	Data
N/A	Ramp Length (in)	48.0	No	Ramp Slope (%)	9.9
Yes	Ramp Width (in)	48.0	No	Ramp XSlope (%)	3.2
N/A	Flare Type LT	N/A	N/A	Flare Type RT	N/A
N/A	Flare Slope LT (%)	N/A	N/A	Flare Slope RT (%)	N/A
N/A	Flare Traversable LT?	N/A	N/A	Flare Traversable RT?	N/A
N/A	Landing Length (in)	N/A	N/A	DWS Provided?	N/A
N/A	Landing Width (in)	N/A	N/A	DWS Contrast?	N/A
N/A	Landing Slope (%)	N/A	N/A	DWS Length (in)	N/A
N/A	Landing X Slope (%)	N/A	N/A	DWS Full Width?	N/A
N/A	Landing Curb? (Y/N)	N/A	N/A	DWS Offset (in)	N/A
N/A	Shared Landing?	N/A			
N/A	Gutter Ponding?	N/A	N/A	Gutter Slope (%)	N/A
N/A	Gutter Lip Ht (in)	N/A	N/A	Gutter X Slope (%)	N/A
N/A	Painted X Walk1?	Yes	N/A	Painted X Walk2?	N/A
	X Walk 1 Direction	To NW		X Walk 2 Direction	N/A
N/A	X Walk 1 Width (in)	96.0	N/A	X Walk 2 Width (in)	N/A
	X Walk 1 Slope (%)	4.4		X Walk 2 Slope (%)	N/A
	X Walk 1 X Slope (%)	0.0		X Walk 2 X Slope (%)	N/A

N/A	Ramp inside XWalk1?	Yes	N/A	Ramp inside XWalk2?	N/A
	Road Slope (%)	N/A	N/A	Clear Space?	N/A
	Road X Slope (%)	N/A	N/A	Clear Space to XWalk (in)	N/A
N/A	Any Obstructions?	N/A	N/A	Storm Grate/Utility Hazard?	N/A
	Obstruction Type			Storm Grate/Utility Type	
		N/A			N/A
			Yes	Surface Condition? (G/P)	Good

Remove & Replace Entire Ramp.
