# Access Compliance Report

## Public Rights-of-Way

### (Curb Ramps)

Intersection ID: 19324	Main Street: OLD_GATE_DR	Cross Street: OLD_HOUSE_CR	Location: NW
ADA ID: E3F7478F7708	Ramp Type: PerpDiag	Initial Pass/Fail: Fail	Overall Compliance: No
Severity Score: 21.25			
Codes/Mitigation Info/Possible Solution		Field Measurements/Component Compliance

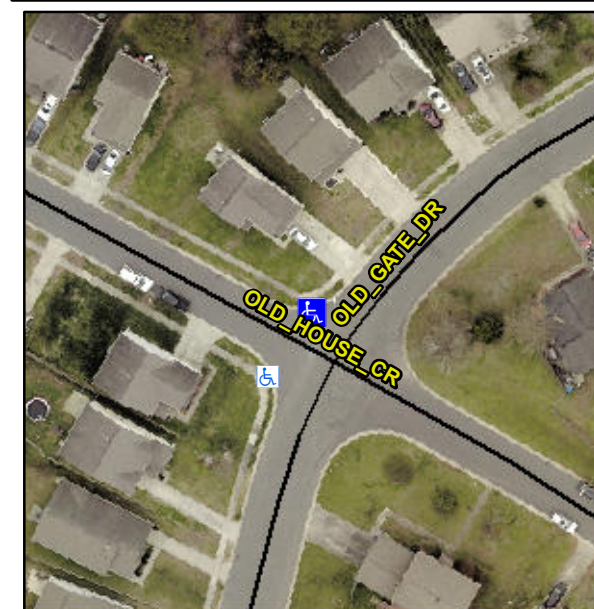
**Not Found, R304.5.1, R304.5.3**

Compliance	Description	Data	Compliance	Description	Data
N/A	Ramp Length (in)	81.0	Yes	Ramp Slope (%)	7.6
No	Ramp Width (in)	47.0	No	Ramp XSlope (%)	5.2
N/A	Flare Type LT	N/A	N/A	Flare Type RT	N/A
N/A	Flare Slope LT (%)	N/A	N/A	Flare Slope RT (%)	N/A
N/A	Flare Traversable LT?	N/A	N/A	Flare Traversable RT?	N/A
N/A	Landing Length (in)	N/A	N/A	DWS Provided?	N/A
N/A	Landing Width (in)	N/A	N/A	DWS Contrast?	N/A
N/A	Landing Slope (%)	N/A	N/A	DWS Length (in)	N/A
N/A	Landing X Slope (%)	N/A	N/A	DWS Full Width?	N/A
N/A	Landing Curb? (Y/N)	N/A	N/A	DWS Offset (in)	N/A
N/A	Shared Landing?	N/A			
N/A	Gutter Ponding?	N/A	N/A	Gutter Slope (%)	N/A
N/A	Gutter Lip Ht (in)	N/A	N/A	Gutter X Slope (%)	N/A
N/A	Painted X Walk1?	No	N/A	Painted X Walk2?	No
	X Walk 1 Direction	To SW		X Walk 2 Direction	To SE
N/A	X Walk 1 Width (in)	N/A	N/A	X Walk 2 Width (in)	N/A
	X Walk 1 Slope (%)	1.1		X Walk 2 Slope (%)	2.8
	X Walk 1 X Slope (%)	2.3		X Walk 2 X Slope (%)	0.8

N/A	Ramp inside XWalk1?	N/A	N/A	Ramp inside XWalk2?	N/A
	Road Slope (%)	1.8	N/A	Clear Space?	N/A
	Road X Slope (%)	1.7	N/A	Clear Space to XWalk (in)	N/A
N/A	Any Obstructions?	N/A	N/A	Storm Grate/Utility Hazard?	N/A
	Obstruction Type			Storm Grate/Utility Type	
		N/A			N/A
		Yes		Surface Condition? (G/P)	Good

**Remove & Replace Curb Ramp With Two New Directional Ramps or Equivalent.**

Total Cost: \$ 3200.00
