Access Compliance Report

Public Rights-of-Way

(Curb Ramps)

Intersection ID: 13882	Main Street: BARCLIFF_DR	Cross Street: FARM_POND_LN	Location: SW
ADA ID: E3FF68069C84	Ramp Type: Perp	Initial Pass/Fail: Fail	Overall Compliance: No
			Severity Score: 13.75

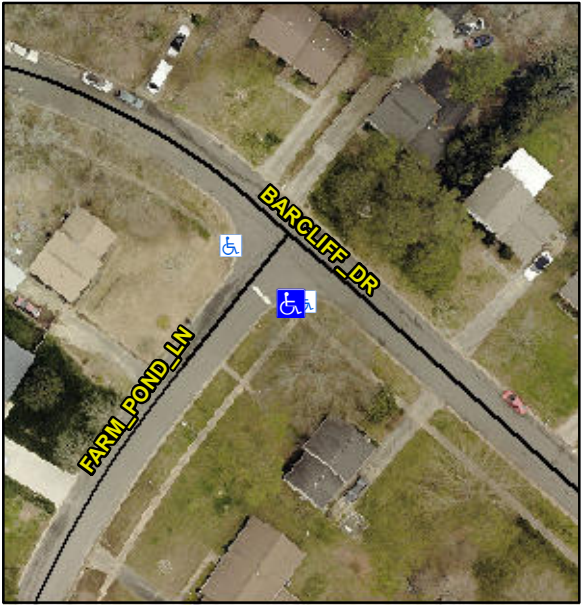
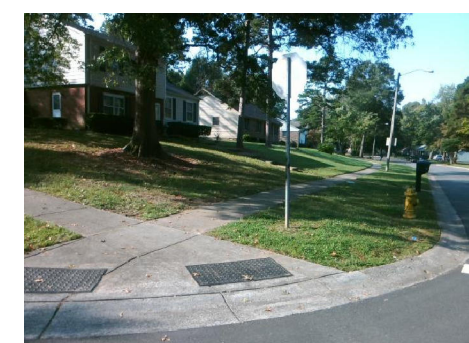
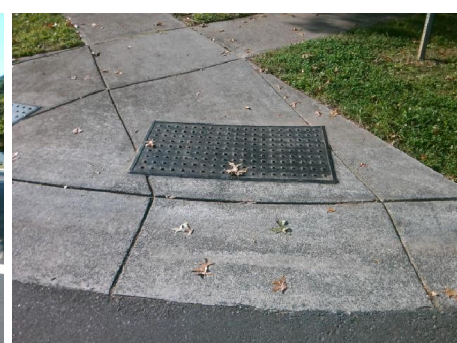
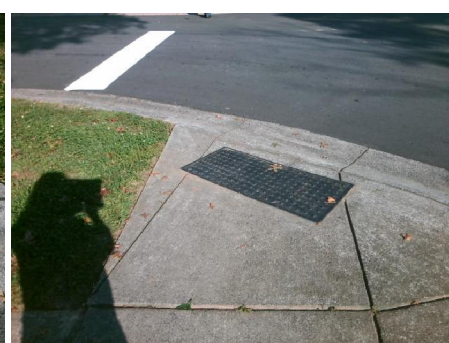
Possible Solutions:		Compliance	Description	Data
	Remove & Replace Entire Ramp.		No	Ramp Length (in)	56.0
			Yes	Ramp Width (in)	51.0
			N/A	Flare Type LT	N/A
			N/A	Flare Slope LT (%)	N/A
			N/A	Flare Traversable LT?	N/A
			N/A	Landing Length (in)	N/A
			N/A	Landing Width (in)	N/A
			N/A	Landing Slope (%)	N/A
			N/A	Landing X Slope (%)	N/A
<p>Surveyor Notes:</p> <p>N/A</p> <p>PROW/ADA:</p> <p>Not Found, R304.2.2, R304.5.3</p>			N/A	Flare Type RT	N/A
			N/A	Flare Slope RT (%)	N/A
			N/A	Flare Traversable RT?	N/A
			N/A	DWS Provided?	N/A
			N/A	DWS Contrast?	N/A
			N/A	DWS Length (in)	N/A
			N/A	DWS Full Width?	N/A
			N/A	DWS Offset (in)	N/A
			N/A	Gutter Ponding?	N/A
			N/A	Gutter Lip Ht (in)	N/A
			No	Painted X Walk1?	N/A
			To NW	X Walk 1 Direction	N/A
			N/A	X Walk 1 Width (in)	N/A

0.7	X Walk 1 Slope (%)	N/A
			2.8	X Walk 1 X Slope (%)	N/A
			N/A	Ramp inside XWalk1?	N/A
			N/A	Road Slope (%)	N/A
			N/A	Road X Slope (%)	N/A
			N/A	Any Obstructions?	N/A
				Obstruction Type	N/A
Total Cost:			\$ 1850.00		
			N/A		N/A
			Yes	Surface Condition? (G/P)	Good
