Access Compliance Report

Public Rights-of-Way

(Curb Ramps)

Intersection ID: 14863	Main Street: WEST_BV	Cross Street: AIRPORT_DR	Location:	N
ADA ID: E40088C88E95	Ramp Type: PerpDiag	Initial Pass/Fail: Fail	Overall Compliance: No	Severity Score: 26.25
Codes/Mitigation Info/Possible Solution		Field Measurements/Component Compliance

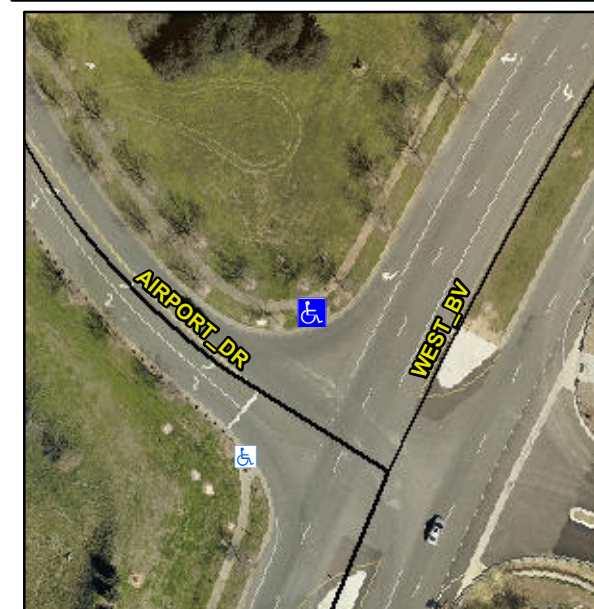
Not Found, R304.2.2, R304.5.3

Compliance	Description	Data	Compliance	Description	Data
N/A	Ramp Length (in)	64.0	No	Ramp Slope (%)	12.8
Yes	Ramp Width (in)	48.0	No	Ramp XSlope (%)	3.7
N/A	Flare Type LT	N/A	N/A	Flare Type RT	N/A
N/A	Flare Slope LT (%)	N/A	N/A	Flare Slope RT (%)	N/A
N/A	Flare Traversable LT?	N/A	N/A	Flare Traversable RT?	N/A
N/A	Landing Length (in)	N/A	N/A	DWS Provided?	N/A
N/A	Landing Width (in)	N/A	N/A	DWS Contrast?	N/A
N/A	Landing Slope (%)	N/A	N/A	DWS Length (in)	N/A
N/A	Landing X Slope (%)	N/A	N/A	DWS Full Width?	N/A
N/A	Landing Curb? (Y/N)	N/A	N/A	DWS Offset (in)	N/A
N/A	Shared Landing?	N/A			
N/A	Gutter Ponding?	N/A	N/A	Gutter Slope (%)	N/A
N/A	Gutter Lip Ht (in)	N/A	N/A	Gutter X Slope (%)	N/A
N/A	Painted X Walk1?	No	N/A	Painted X Walk2?	No
	X Walk 1 Direction	To SW		X Walk 2 Direction	To SE
N/A	X Walk 1 Width (in)	N/A	N/A	X Walk 2 Width (in)	N/A
	X Walk 1 Slope (%)	2.4		X Walk 2 Slope (%)	4.2
	X Walk 1 X Slope (%)	4.7		X Walk 2 X Slope (%)	2.2

N/A	Ramp inside XWalk1?	N/A	N/A	Ramp inside XWalk2?	N/A
	Road Slope (%)	3.9	N/A	Clear Space?	N/A
	Road X Slope (%)	1.8	N/A	Clear Space to XWalk (in)	N/A
N/A	Any Obstructions?	N/A	N/A	Storm Grate/Utility Hazard?	N/A
	Obstruction Type			Storm Grate/Utility Type	
		N/A			N/A
			Yes	Surface Condition? (G/P)	Good

Possible Solutions:

Remove & Replace Curb Ramp With Two New Directional Ramps or Equivalent.
