# Access Compliance Report

## Public Rights-of-Way

### (Curb Ramps)

| Intersection ID: 17673 | Main Street: MONROE_RD | Cross Street: OLD_POST_RD | Location: SE |

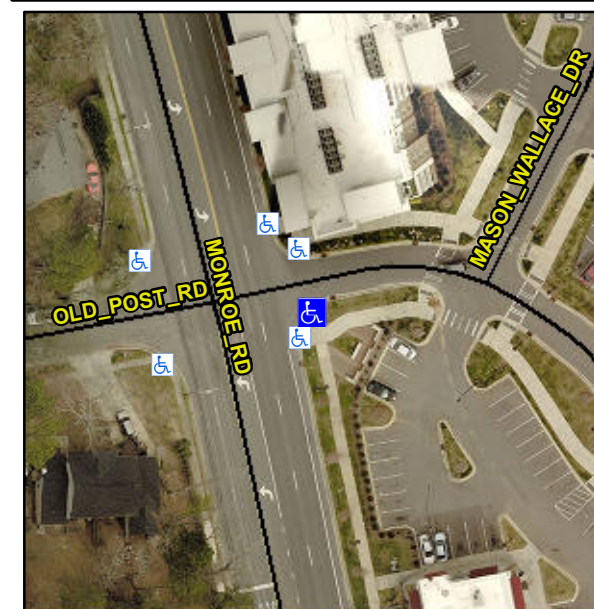
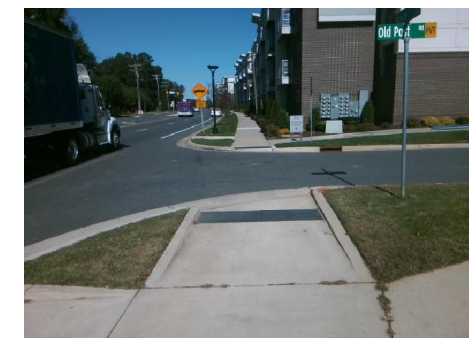
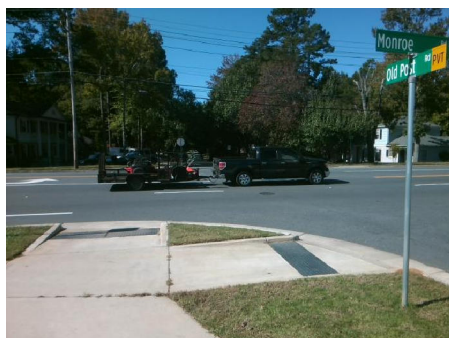
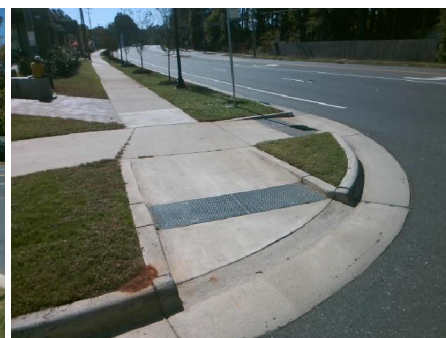
| ADA ID: E405070D16B9 | Ramp Type: Directional1 | Initial Pass/Fail: Fail | Overall Compliance: No |

**R304.5.3**

| Compliance | Description | Data | Compliance | Description | Data |
|---|---|---|---|---|---|
| No | Ramp XSlope (%) | 2.3 | | | |

**Remove & Replace Entire Ramp.**

\$ 1600.00
