# Access Compliance Report

## Public Rights-of-Way

### (Curb Ramps)

| Intersection ID: 13760 | Main Street: EUCLID_AV | Cross Street: TEMPLETON_AV | Location: | N |

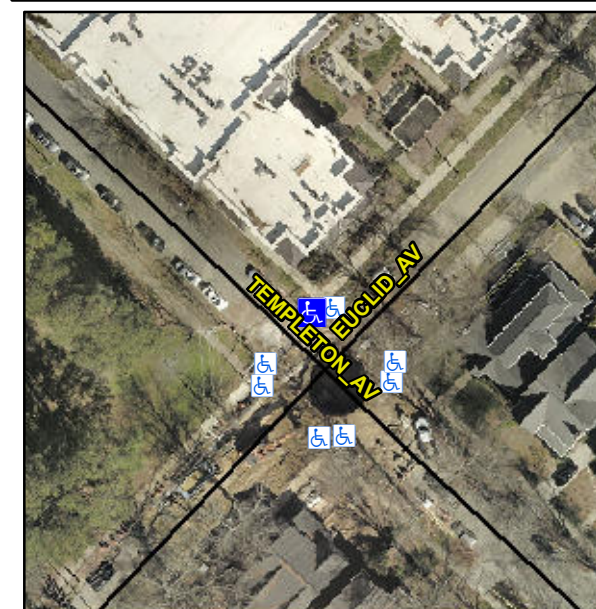
**Remove & Replace Detectable Warning System. Gutter Ponding Observed.**

**R305.2, R302.7**

| Compliance | Description | Data | Compliance | Description | Data |
|---|---|---|---|---|---|
| N/A | Landing Curb? (Y/N) | No | No | DWS Offset (in) | 4.0 |
| No | Gutter Ponding? | Yes | Yes | Gutter Slope (%) | 0.9 |

Possible Solutions:
