Access Compliance Report

Public Rights-of-Way

(Curb Ramps)

Intersection ID: 31810	Main Street: CRANE_POINT_DR	Cross Street: TROTTERS_RIDGE_RD	Location: NE
ADA ID: E40A1EA00EF2	Ramp Type: PerpDiag	Initial Pass/Fail: Fail	Overall Compliance: No
		Severity Score: 12.5

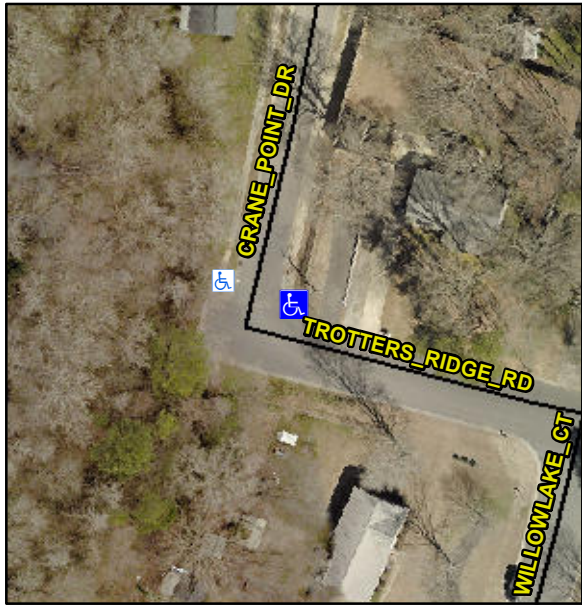
Possible Solutions:	Compliance		Description		Data	Compliance	Description		Data
	Remove & Replace Curb Ramp With Two New Directional Ramps or Equivalent.	N/A	Ramp Length (in)	56.0	No	Ramp Slope (%)	8.4			
		Yes	Ramp Width (in)	48.5	Yes	Ramp XSlope (%)	1.6			
		N/A	Flare Type LT	N/A	N/A	Flare Type RT	N/A			
		N/A	Flare Slope LT (%)	N/A	N/A	Flare Slope RT (%)	N/A			
		N/A	Flare Traversable LT?	N/A	N/A	Flare Traversable RT?	N/A			
		N/A	Landing Length (in)	N/A	N/A	DWS Provided?	N/A			
		N/A	Landing Width (in)	N/A	N/A	DWS Contrast?	N/A			
		N/A	Landing Slope (%)	N/A	N/A	DWS Length (in)	N/A			
		N/A	Landing X Slope (%)	N/A	N/A	DWS Full Width?	N/A			
N/A	Landing Curb? (Y/N)	N/A	N/A	DWS Offset (in)	N/A					
Surveyor Notes:	Compliance		Description		Data	Compliance	Description		Data	
N/A	N/A	Gutter Ponding?	N/A	N/A	Gutter Slope (%)	N/A

PROW/ADA:	Not Found, R304.2.2	N/A	Gutter Lip Ht (in)	N/A	N/A	Gutter X Slope (%)	N/A			
		N/A	Painted X Walk1?	No	N/A	Painted X Walk2?	No			
			X Walk 1 Direction	To NW		X Walk 2 Direction	To SW			
		N/A	X Walk 1 Width (in)	N/A	N/A	X Walk 2 Width (in)	N/A			
			X Walk 1 Slope (%)	1.4		X Walk 2 Slope (%)	3.3			
			X Walk 1 X Slope (%)	7.0		X Walk 2 X Slope (%)	0.1			
		N/A	Ramp inside XWalk1?	N/A	N/A	Ramp inside XWalk2?	N/A			
			Road Slope (%)	6.7	N/A	Clear Space?	N/A			
			Road X Slope (%)	10.5	N/A	Clear Space to XWalk (in)	N/A			
		N/A	Any Obstructions?	N/A	N/A	Storm Grate/Utility Hazard?	N/A			
Total Cost:	\$	3200.00	Obstruction Type		Storm Grate/Utility Type					
					N/A		N/A			
					Yes	Surface Condition? (G/P)	Good
