Access Compliance Report

Public Rights-of-Way

(Curb Ramps)

Intersection ID: 30447	Main Street: GRAPEYARD_CT	Cross Street: CADES_COVE_DR	Location: NE
ADA ID: E40BB7471C82	Ramp Type: PerpDiag	Initial Pass/Fail: Fail	Overall Compliance: No
		Severity Score: 10

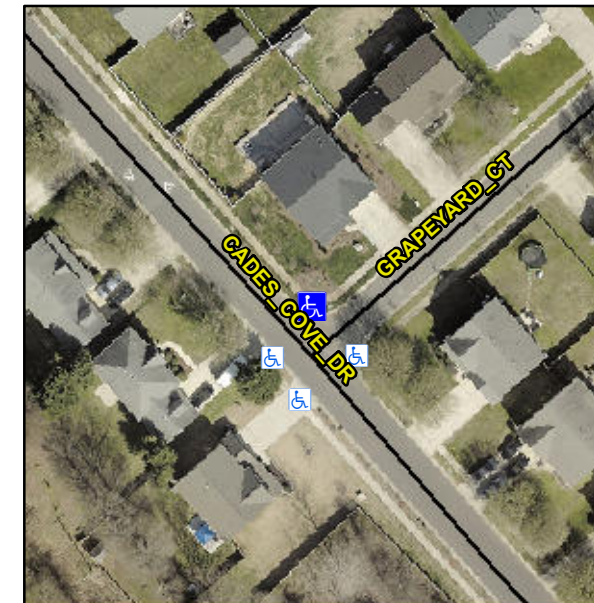
Compliance	Description	Data	Compliance	Description	Data
N/A	Ramp Length (in)	46.5	Yes	Ramp Slope (%)	5.3
No	Ramp Width (in)	44.0	No	Ramp XSlope (%)	2.8
N/A	Flare Type LT	N/A	N/A	Flare Type RT	N/A
N/A	Flare Slope LT (%)	N/A	N/A	Flare Slope RT (%)	N/A
N/A	Flare Traversable LT?	N/A	N/A	Flare Traversable RT?	N/A
N/A	Landing Length (in)	N/A	N/A	DWS Provided?	N/A
N/A	Landing Width (in)	N/A	N/A	DWS Contrast?	N/A
N/A	Landing Slope (%)	N/A	N/A	DWS Length (in)	N/A
N/A	Landing X Slope (%)	N/A	N/A	DWS Full Width?	N/A
N/A	Landing Curb? (Y/N)	N/A	N/A	DWS Offset (in)	N/A
N/A	Shared Landing?	N/A			
N/A	Gutter Ponding?	N/A	N/A	Gutter Slope (%)	N/A
N/A	Gutter Lip Ht (in)	N/A	N/A	Gutter X Slope (%)	N/A
N/A	Painted X Walk1?	No	N/A	Painted X Walk2?	No
	X Walk 1 Direction	To SW		X Walk 2 Direction	To SE
N/A	X Walk 1 Width (in)	N/A	N/A	X Walk 2 Width (in)	N/A
	X Walk 1 Slope (%)	1.9		X Walk 2 Slope (%)	1.5
	X Walk 1 X Slope (%)	0.6		X Walk 2 X Slope (%)	0.9

N/A	Ramp inside XWalk1?	N/A	N/A	Ramp inside XWalk2?	N/A
	Road Slope (%)	0.1	N/A	Clear Space?	N/A
	Road X Slope (%)	0.2	N/A	Clear Space to XWalk (in)	N/A
N/A	Any Obstructions?	N/A	N/A	Storm Grate/Utility Hazard?	N/A
	Obstruction Type			Storm Grate/Utility Type	
		N/A			N/A
			Yes	Surface Condition? (G/P)	Good

Remove & Replace Curb Ramp With Two New Directional Ramps or Equivalent.

R304.5.1, R304.5.3
