Access Compliance Report

Public Rights-of-Way

(Curb Ramps)

Intersection ID: 24591	Main Street: REA_CROFT_DR	Cross Street: SPRINGSIDE_LN	Location: SE
ADA ID: E40DF4BEF95F	Ramp Type: BlendTrans2	Initial Pass/Fail: Pass	Overall Compliance: No
		Severity Score: 10

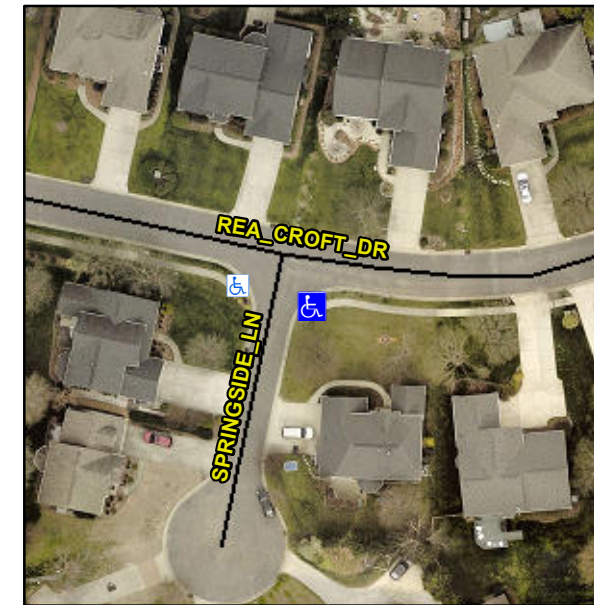
Compliance	Description	Data	Compliance	Description	Data
N/A	Ramp Length (in)	96.0	Yes	BlendTrans Slope (%)	2.6
Yes	Ramp Width (in)	48.0	Yes	BlendTrans XSlope (%)	1.6
N/A	Flare Type LT	None	N/A	Flare Type RT	None
N/A	Flare Slope LT (%)	N/A	N/A	Flare Slope RT (%)	N/A
N/A	Flare Traversable LT?	N/A	N/A	Flare Traversable RT?	N/A
N/A	Landing Length (in)	N/A	No	DWS Provided?	No
N/A	Landing Width (in)	N/A	N/A	DWS Contrast?	No
N/A	Landing Slope (%)	N/A	N/A	DWS Length (in)	N/A
N/A	Landing X Slope (%)	N/A	N/A	DWS Full Width?	No
N/A	Landing Curb? (Y/N)	No	N/A	DWS Offset (in)	N/A
N/A	Shared Landing?	No			
Yes	Gutter Ponding?	No	Yes	Gutter Slope (%)	3.1
Yes	Gutter Lip Ht (in)	0.0	Yes	Gutter X Slope (%)	0.7
N/A	Painted X Walk1?	No	N/A	Painted X Walk2?	No
	X Walk 1 Direction	To N		X Walk 2 Direction	To W
	X Walk 1 Width (in)	N/A		X Walk 2 Width (in)	N/A
	X Walk 1 Slope (%)	2.8		X Walk 2 Slope (%)	3.6
	X Walk 1 X Slope (%)	1.1		X Walk 2 X Slope (%)	2.2

N/A	Ramp inside XWalk1?	N/A	N/A	Ramp inside XWalk2?	N/A
	Road Slope (%)	0.7		Clear Space?	Yes
	Road X Slope (%)	4.9	N/A	Clear Space to XWalk (in)	N/A
Yes	Any Obstructions?	No	Yes	Storm Grate/Utility Hazard?	No
	Obstruction Type			Storm Grate/Utility Type	
		N/A			N/A
			Yes	Surface Condition? (G/P)	Good
			No	Curb Slope (%)	12.2

Remove & Replace Curb Ramp With Two New Directional Ramps or Equivalent.
