# Access Compliance Report

## Public Rights-of-Way

### (Curb Ramps)

Intersection ID: 44540	Main Street: NEAL_RD	Cross Street: UNIVERSITY_CITY_BV	Location: E
ADA ID: E40E621C233D	Ramp Type: Perp	Initial Pass/Fail: Fail	Overall Compliance: No
Severity Score: 21.25			
Codes/Mitigation Info/Possible Solution		Field Measurements/Component Compliance

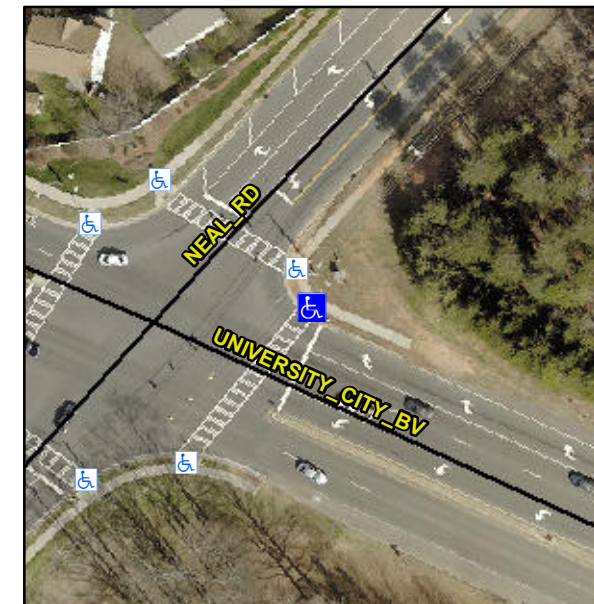
**Not Found, R304.5.1, R304.2.2**

Compliance	Description	Data	Compliance	Description	Data
N/A	Ramp Length (in)	55.0	No	Ramp Slope (%)	8.5
No	Ramp Width (in)	47.0	Yes	Ramp XSlope (%)	1.7
N/A	Flare Type LT	N/A	N/A	Flare Type RT	N/A
N/A	Flare Slope LT (%)	N/A	N/A	Flare Slope RT (%)	N/A
N/A	Flare Traversable LT?	N/A	N/A	Flare Traversable RT?	N/A
N/A	Landing Length (in)	N/A	N/A	DWS Provided?	N/A
N/A	Landing Width (in)	N/A	N/A	DWS Contrast?	N/A
N/A	Landing Slope (%)	N/A	N/A	DWS Length (in)	N/A
N/A	Landing X Slope (%)	N/A	N/A	DWS Full Width?	N/A
N/A	Landing Curb? (Y/N)	N/A	N/A	DWS Offset (in)	N/A
N/A	Shared Landing?	N/A			
N/A	Gutter Ponding?	Yes	N/A	Gutter Slope (%)	N/A
N/A	Gutter Lip Ht (in)	N/A	N/A	Gutter X Slope (%)	N/A
N/A	Painted X Walk1?	Yes	N/A	Painted X Walk2?	N/A
	X Walk 1 Direction	To SW		X Walk 2 Direction	N/A
N/A	X Walk 1 Width (in)	103.0	N/A	X Walk 2 Width (in)	N/A
	X Walk 1 Slope (%)	3.4		X Walk 2 Slope (%)	N/A
	X Walk 1 X Slope (%)	0.3		X Walk 2 X Slope (%)	N/A

N/A	Ramp inside XWalk1?	Yes	N/A	Ramp inside XWalk2?	N/A
	Road Slope (%)	N/A	N/A	Clear Space?	N/A
	Road X Slope (%)	N/A	N/A	Clear Space to XWalk (in)	N/A
N/A	Any Obstructions?	N/A	N/A	Storm Grate/Utility Hazard?	N/A
	Obstruction Type			Storm Grate/Utility Type	
		N/A			N/A
		Yes		Surface Condition? (G/P)	Good

**Remove & Replace Entire Ramp.**

Total Cost: \$ 1850.00
