# Access Compliance Report

## Public Rights-of-Way

### (Curb Ramps)

Intersection ID: 3828	Main Street: DAVIS_LAKE_PY	Cross Street: OLD_FOX_TL	Location: NW
ADA ID: E418EC0DA740	Ramp Type: Perp	Initial Pass/Fail: Fail	Overall Compliance: No
Codes/Mitigation Info/Possible Solution		Field Measurements/Component Compliance

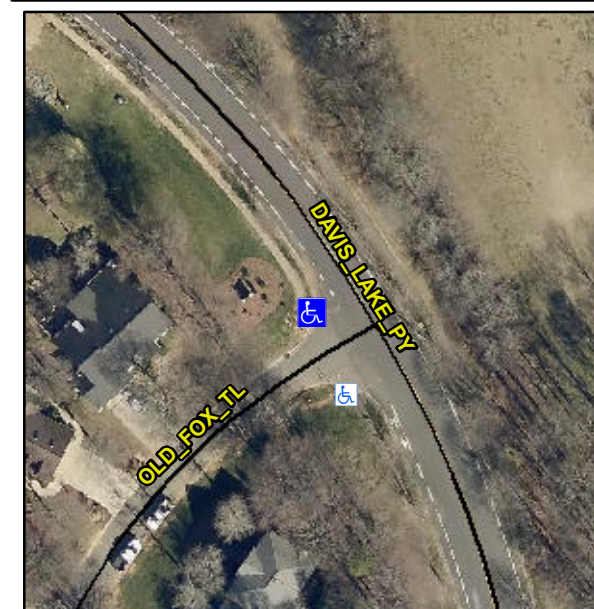
**Not Found, R304.5.1, R304.2.2, R304.5.3**

Compliance	Description	Data	Compliance	Description	Data
N/A	Ramp Length (in)	49.5	No	Ramp Slope (%)	8.8
No	Ramp Width (in)	40.0	No	Ramp XSlope (%)	3.3
N/A	Flare Type LT	N/A	N/A	Flare Type RT	N/A
N/A	Flare Slope LT (%)	N/A	N/A	Flare Slope RT (%)	N/A
N/A	Flare Traversable LT?	N/A	N/A	Flare Traversable RT?	N/A
N/A	Landing Length (in)	N/A	N/A	DWS Provided?	N/A
N/A	Landing Width (in)	N/A	N/A	DWS Contrast?	N/A
N/A	Landing Slope (%)	N/A	N/A	DWS Length (in)	N/A
N/A	Landing X Slope (%)	N/A	N/A	DWS Full Width?	N/A
N/A	Landing Curb? (Y/N)	N/A	N/A	DWS Offset (in)	N/A
N/A	Shared Landing?	N/A			
N/A	Gutter Ponding?	N/A	N/A	Gutter Slope (%)	N/A
N/A	Gutter Lip Ht (in)	N/A	N/A	Gutter X Slope (%)	N/A
N/A	Painted X Walk1?	No	N/A	Painted X Walk2?	N/A
	X Walk 1 Direction	To S		X Walk 2 Direction	N/A
N/A	X Walk 1 Width (in)	N/A	N/A	X Walk 2 Width (in)	N/A
	X Walk 1 Slope (%)	7.3		X Walk 2 Slope (%)	N/A
	X Walk 1 X Slope (%)	2.0		X Walk 2 X Slope (%)	N/A

**Remove & Replace Entire Ramp.**

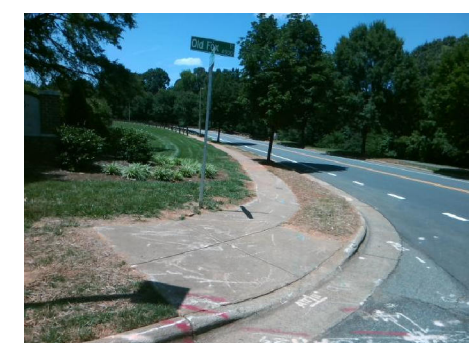
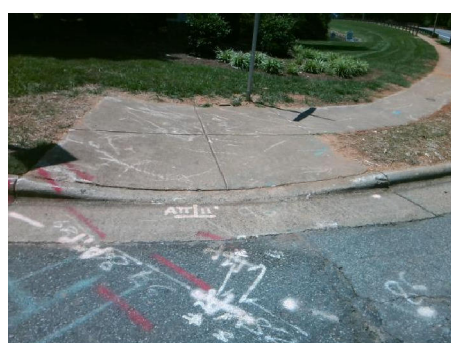
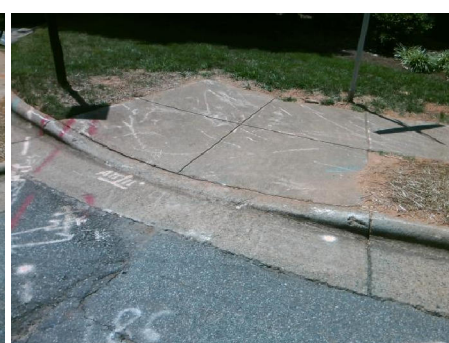
N/A	Ramp inside XWalk1?	N/A	N/A	Ramp inside XWalk2?	N/A
	Road Slope (%)	N/A	N/A	Clear Space?	N/A
	Road X Slope (%)	N/A	N/A	Clear Space to XWalk (in)	N/A
N/A	Any Obstructions?	N/A	N/A	Storm Grate/Utility Hazard?	N/A
	Obstruction Type			Storm Grate/Utility Type	
		N/A			N/A
			Yes	Surface Condition? (G/P)	Good
