# Access Compliance Report

## Public Rights-of-Way

### (Curb Ramps)

Intersection ID: 31631	Main Street: PLAZA_WALK_DR	Cross Street: N/A	Location: NE
ADA ID: E41F148AA938	Ramp Type: Perp	Initial Pass/Fail: Fail	Overall Compliance: No
Severity Score: 10			
Codes/Mitigation Info/Possible Solution		Field Measurements/Component Compliance

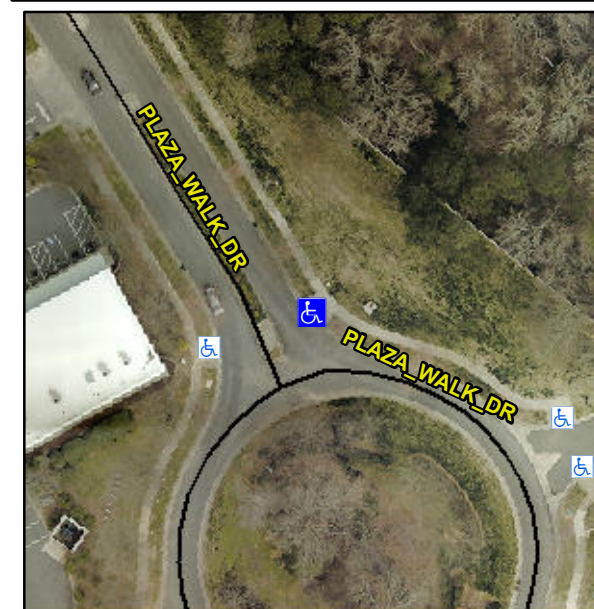
**Not Found, R304.5.1, R304.5.3**

Compliance	Description	Data	Compliance	Description	Data
N/A	Ramp Length (in)	96.0	Yes	Ramp Slope (%)	6.1
No	Ramp Width (in)	47.5	No	Ramp XSlope (%)	3.4
N/A	Flare Type LT	N/A	N/A	Flare Type RT	N/A
N/A	Flare Slope LT (%)	N/A	N/A	Flare Slope RT (%)	N/A
N/A	Flare Traversable LT?	N/A	N/A	Flare Traversable RT?	N/A
N/A	Landing Length (in)	N/A	N/A	DWS Provided?	N/A
N/A	Landing Width (in)	N/A	N/A	DWS Contrast?	N/A
N/A	Landing Slope (%)	N/A	N/A	DWS Length (in)	N/A
N/A	Landing X Slope (%)	N/A	N/A	DWS Full Width?	N/A
N/A	Landing Curb? (Y/N)	N/A	N/A	DWS Offset (in)	N/A
N/A	Shared Landing?	N/A			
N/A	Gutter Ponding?	N/A	N/A	Gutter Slope (%)	N/A
N/A	Gutter Lip Ht (in)	1.0	N/A	Gutter X Slope (%)	N/A
N/A	Painted X Walk1?	No	N/A	Painted X Walk2?	N/A
	X Walk 1 Direction	To W		X Walk 2 Direction	N/A
N/A	X Walk 1 Width (in)	N/A	N/A	X Walk 2 Width (in)	N/A
	X Walk 1 Slope (%)	0.1		X Walk 2 Slope (%)	N/A
	X Walk 1 X Slope (%)	3.0		X Walk 2 X Slope (%)	N/A

**Remove & Replace Entire Ramp.**
