# Access Compliance Report

## Public Rights-of-Way

### (Curb Ramps)

Intersection ID: 22832	Main Street: IMPERIAL_OAK_LN	Cross Street: OAKBRIAR_LN	Location: SE
ADA ID: E4267BC726E4	Ramp Type: Perp	Initial Pass/Fail: Fail	Overall Compliance: No
Severity Score: 1.25			
Codes/Mitigation Info/Possible Solution		Field Measurements/Component Compliance

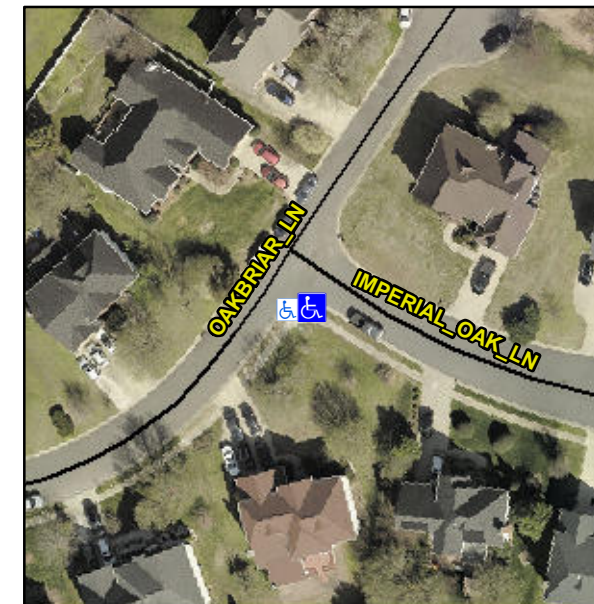
**Not Found, R304.5.3**

Compliance	Description	Data	Compliance	Description	Data
N/A	Ramp Length (in)	50.0	Yes	Ramp Slope (%)	5.4
Yes	Ramp Width (in)	48.0	No	Ramp XSlope (%)	3.1
N/A	Flare Type LT	N/A	N/A	Flare Type RT	N/A
N/A	Flare Slope LT (%)	N/A	N/A	Flare Slope RT (%)	N/A
N/A	Flare Traversable LT?	N/A	N/A	Flare Traversable RT?	N/A
N/A	Landing Length (in)	N/A	N/A	DWS Provided?	N/A
N/A	Landing Width (in)	N/A	N/A	DWS Contrast?	N/A
N/A	Landing Slope (%)	N/A	N/A	DWS Length (in)	N/A
N/A	Landing X Slope (%)	N/A	N/A	DWS Full Width?	N/A
N/A	Landing Curb? (Y/N)	N/A	N/A	DWS Offset (in)	N/A
N/A	Shared Landing?	N/A			
N/A	Gutter Ponding?	N/A	N/A	Gutter Slope (%)	N/A
N/A	Gutter Lip Ht (in)	N/A	N/A	Gutter X Slope (%)	N/A
N/A	Painted X Walk1?	No	N/A	Painted X Walk2?	N/A
	X Walk 1 Direction	To NE		X Walk 2 Direction	N/A
N/A	X Walk 1 Width (in)	N/A	N/A	X Walk 2 Width (in)	N/A
	X Walk 1 Slope (%)	4.0		X Walk 2 Slope (%)	N/A
	X Walk 1 X Slope (%)	0.9		X Walk 2 X Slope (%)	N/A

**Remove & Replace Entire Ramp.**
