## Access Compliance Report Public Rights-of-Way (Curb Ramps)

Intersection ID: 14749Main Street: HOLLYFIELD\_DRCross Street: REDWOOD\_TERRACE\_RDLocation:NWADA ID: E428F100F549Ramp Type: PerpDiagInitial Pass/Fail: FailOverall Compliance: NoSeverity Score:10

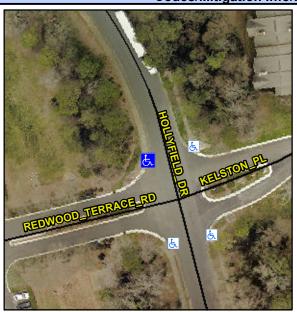
Not Found, R304.5.1, R304.5.3

Field Measurements/Component Compliance						
	Compliance Description		Data	Comp	oliance Description	Data
	N/A	Ramp Length (in)	71.0	Yes	Ramp Slope (%)	7.1
	No	Ramp Width (in)	36.0	No	Ramp XSlope (%)	4.3
	N/A	Flare Type LT	N/A	N/A	Flare Type RT	N/A
	N/A	Flare Slope LT (%)	N/A	N/A	Flare Slope RT (%)	N/A
	N/A	Flare Traversable LT?	N/A	N/A	Flare Traversable RT?	N/A
	N/A	Landing Length (in)	N/A	N/A	DWS Provided?	N/A
	N/A	Landing Width (in)	N/A	N/A	DWS Contrast?	N/A
	N/A	Landing Slope (%)	N/A	N/A	DWS Length (in)	N/A
	N/A	Landing X Slope (%)	N/A	N/A	DWS Full Width?	N/A
	N/A	Landing Curb? (Y/N)	N/A	N/A	DWS Offset (in)	N/A
	N/A	Shared Landing?	N/A			
	N/A	Gutter Ponding?	N/A	N/A	Gutter Slope (%)	N/A
	N/A	Gutter Lip Ht (in)	2.5	N/A	Gutter X Slope (%)	N/A
	N/A	Painted X Walk1?	No	N/A	Painted X Walk2?	No
		X Walk 1 Direction	To S		X Walk 2 Direction	To E
	N/A	X Walk 1 Width (in)	N/A	N/A	X Walk 2 Width (in)	N/A
		X Walk 1 Slope (%)	2.6		X Walk 2 Slope (%)	2.7

X Walk 1 X Slope (%)	0.3		X Walk 2 X Slope (%)	4.7
	N/A	Ramp inside XWalk1?	N/A	N/A	Ramp inside XWalk2?	N/A
		Road Slope (%)	3.8	N/A	Clear Space?	N/A
		Road X Slope (%)	1.0	N/A	Clear Space to XWalk (in)	N/A
	N/A	Any Obstructions?	N/A	N/A	Storm Grate/Utility Hazard?	N/A
		Obstruction Type			Storm Grate/Utility Type	
			N/A			N/A
				Yes	Surface Condition? (G/P)	Good
91	and the same of		•

Remove & Replace Curb Ramp With Two New Directional Ramps or Equivalent.
