Access Compliance Report

Public Rights-of-Way

(Curb Ramps)

Intersection ID: 28659	Main Street: HAMPTON_PLACE_DR	Cross Street: RIDGELINE_LN	Location:	E
ADA ID: E42D90E1C45A	Ramp Type: PerpDiag	Initial Pass/Fail: Fail	Overall Compliance: No	Severity Score: 10
Codes/Mitigation Info/Possible Solution		Field Measurements/Component Compliance

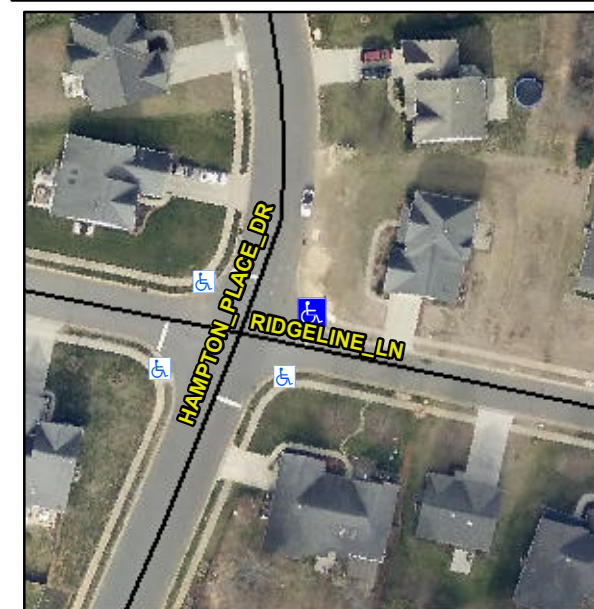
Not Found, R304.5.1, R304.5.3

Compliance	Description	Data	Compliance	Description	Data
N/A	Ramp Length (in)	48.5	Yes	Ramp Slope (%)	5.1
No	Ramp Width (in)	47.0	No	Ramp XSlope (%)	4.1
N/A	Flare Type LT	N/A	N/A	Flare Type RT	N/A
N/A	Flare Slope LT (%)	N/A	N/A	Flare Slope RT (%)	N/A
N/A	Flare Traversable LT?	N/A	N/A	Flare Traversable RT?	N/A
N/A	Landing Length (in)	N/A	N/A	DWS Provided?	N/A
N/A	Landing Width (in)	N/A	N/A	DWS Contrast?	N/A
N/A	Landing Slope (%)	N/A	N/A	DWS Length (in)	N/A
N/A	Landing X Slope (%)	N/A	N/A	DWS Full Width?	N/A
N/A	Landing Curb? (Y/N)	N/A	N/A	DWS Offset (in)	N/A
N/A	Shared Landing?	N/A			
N/A	Gutter Ponding?	N/A	N/A	Gutter Slope (%)	N/A
N/A	Gutter Lip Ht (in)	N/A	N/A	Gutter X Slope (%)	N/A
N/A	Painted X Walk1?	No	N/A	Painted X Walk2?	No
	X Walk 1 Direction	To NW		X Walk 2 Direction	To SW
N/A	X Walk 1 Width (in)	N/A	N/A	X Walk 2 Width (in)	N/A
	X Walk 1 Slope (%)	2.4		X Walk 2 Slope (%)	0.3
	X Walk 1 X Slope (%)	0.7		X Walk 2 X Slope (%)	3.3

N/A	Ramp inside XWalk1?	N/A	N/A	Ramp inside XWalk2?	N/A
	Road Slope (%)	2.8	N/A	Clear Space?	N/A
	Road X Slope (%)	1.4	N/A	Clear Space to XWalk (in)	N/A
N/A	Any Obstructions?	N/A	N/A	Storm Grate/Utility Hazard?	N/A
	Obstruction Type			Storm Grate/Utility Type	
		N/A			N/A
			Yes	Surface Condition? (G/P)	Good

Remove & Replace Curb Ramp With Two New Directional Ramps or Equivalent.
