## Access Compliance Report Public Rights-of-Way (Curb Ramps)

Intersection ID: 13057 Main Street: E\_MOREHEAD\_ST Cross Street: S\_COLLEGE\_ST Location: SW

ADA ID: E433818DB916 Ramp Type: PerpDiag Initial Pass/Fail: Fail Overall Compliance: No Severity Score: 16.25

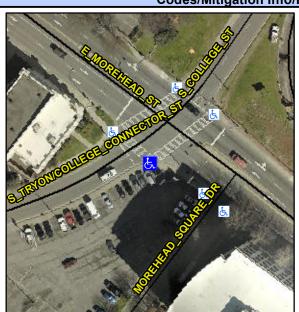
ried Measurements/Component Compnance						
	Compliance Description		Data	Compliance Description		Data
	N/A	Ramp Length (in)	62.0	Yes	Ramp Slope (%)	8.2
	Yes	Ramp Width (in)	48.0	No	Ramp XSlope (%)	2.3
	N/A	Flare Type LT	N/A	N/A	Flare Type RT	N/A
	N/A	Flare Slope LT (%)	N/A	N/A	Flare Slope RT (%)	N/A
	N/A	Flare Traversable LT?	N/A	N/A	Flare Traversable RT?	N/A
	N/A	Landing Length (in)	N/A	N/A	DWS Provided?	N/A
	N/A	Landing Width (in)	N/A	N/A	DWS Contrast?	N/A
	N/A	Landing Slope (%)	N/A	N/A	DWS Length (in)	N/A
	N/A	Landing X Slope (%)	N/A	N/A	DWS Full Width?	N/A
	N/A	Landing Curb? (Y/N)	N/A	N/A	DWS Offset (in)	N/A
	N/A	Shared Landing?	N/A			
	N/A	Gutter Ponding?	N/A	N/A	Gutter Slope (%)	N/A
	N/A	Gutter Lip Ht (in)	N/A	N/A	Gutter X Slope (%)	N/A
	N/A	Painted X Walk1?	Yes	N/A	Painted X Walk2?	Yes
		X Walk 1 Direction	To NE		X Walk 2 Direction	To NW
	N/A	X Walk 1 Width (in)	104.0	N/A	X Walk 2 Width (in)	103.0

X Walk 1 Slope (%)	2.6		X Walk 2 Slope (%)	0.7
		X Walk 1 X Slope (%)	0.2		X Walk 2 X Slope (%)	0.1
	N/A	Ramp inside XWalk1?	Yes	N/A	Ramp inside XWalk2?	Yes
		Road Slope (%)	1.6	N/A	Clear Space?	N/A
		Road X Slope (%)	0.1	N/A	Clear Space to XWalk (in)	N/A
	N/A	Any Obstructions?	N/A	N/A	Storm Grate/Utility Hazard?	N/A

Remove & Replace Curb Ramp With
Two New Directional Ramps or
Equivalent.

PROW/ADA:
Not Found, R304.5.3, R302.7
