## **Access Compliance Report Public Rights-of-Way** (Curb Ramps)

Intersection ID: 54049 Main Street: DISTRICT SOUTH DR Cross Street: DISTRICT\_SOUTH\_DR Location: NE ADA ID: E43C17C5880C Ramp Type: Directional1 Initial Pass/Fail: Fail **Overall Compliance: No** Severity Score: 13.75

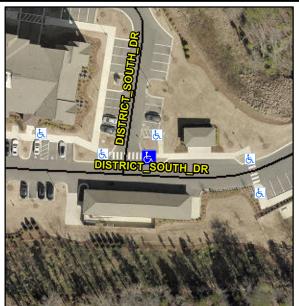
•		•	Yes	Ramp Width (in)	59.0	N/A	Grade Break Slope (%)	0.0
			No	Ramp Slope (%)	9.3	N/A	Grade Break XSlope (%)	0.0
			No	Ramp XSlope (%)	2.5			
			N/A	Flare Type LT	N/A	N/A	Flare Type RT	N/A
			N/A	Flare Slope LT (%)	N/A	N/A	Flare Slope RT (%)	0.0
Surveyor Notes:			N/A	Flare Traversable LT?	N/A	N/A	Flare Traversable RT?	N/A
N/A			N/A	Landing Length (in)	0.0	N/A	DWS Provided?	N/A
<b>\</b>			N/A	Landing Width (in)	0.0	N/A	DWS Contrast?	N/A
			N/A	Landing Slope (%)	0.0	N/A	DWS Length (in)	N/A
			N/A	Landing X Slope (%)	0.0	N/A	DWS Full Width?	N/A
PROW/ADA:			N/A	Landing Curb? (Y/N)	N/A	N/A	DWS Offset LT (in)	N/A
R304.2.2, R304.5.3			N/A	Shared Landing?	N/A	N/A	DWS Offset RT (in)	N/A
			N/A	Gutter Ponding?	0.0	N/A	Gutter Slope (%)	N/A
			N/A	Gutter Lip Ht (in)	0.0	N/A	Gutter X Slope (%)	N/A

o/Possible Solution			Field Measurements/Component Compliance					
Possible Solutions:			Comp	liance Description	Data	Comp	liance Description	Data
Remove & Replace Entire	e Ran	np.	N/A	Ramp Length (in)	82.5	N/A	Grade Break?	N/A
