Access Compliance Report

Public Rights-of-Way

(Curb Ramps)

Intersection ID: 13541	Main Street: CENTRAL_AV	Cross Street: EASTCREST_DR	Location: SE
ADA ID: E43F741B730B	Ramp Type: Perp	Initial Pass/Fail: Fail	Overall Compliance: No
Codes/Mitigation Info/Possible Solution			Severity Score: 10
			Field Measurements/Component Compliance

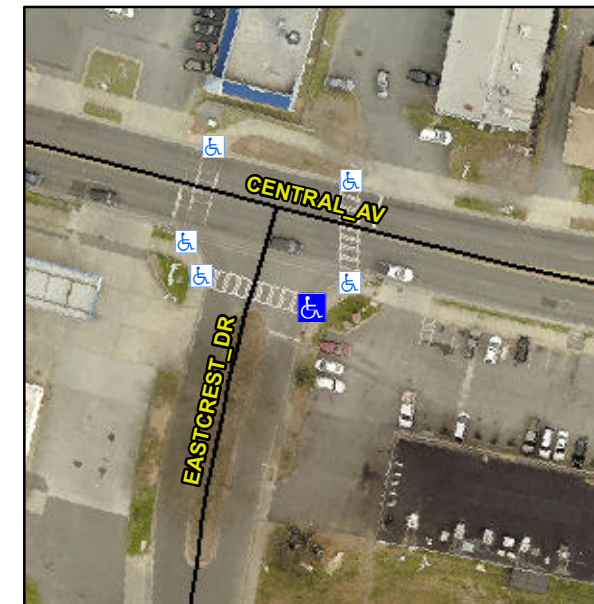
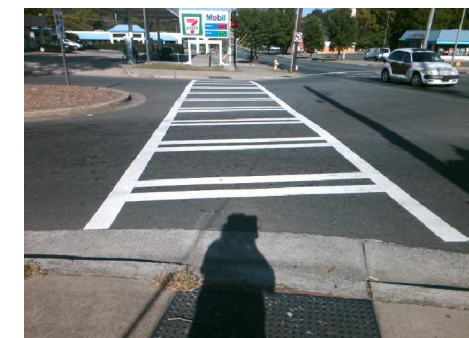
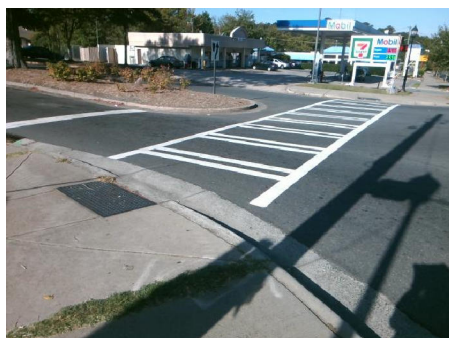
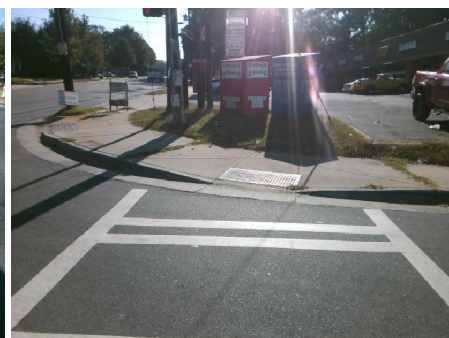
Not Found, R304.5.1, R304.5.3

Compliance	Description	Data	Compliance	Description	Data
N/A	Ramp Length (in)	60.0	Yes	Ramp Slope (%)	6.4
No	Ramp Width (in)	38.5	No	Ramp XSlope (%)	3.4
N/A	Flare Type LT	N/A	N/A	Flare Type RT	N/A
N/A	Flare Slope LT (%)	N/A	N/A	Flare Slope RT (%)	N/A
N/A	Flare Traversable LT?	N/A	N/A	Flare Traversable RT?	N/A
N/A	Landing Length (in)	N/A	N/A	DWS Provided?	N/A
N/A	Landing Width (in)	N/A	N/A	DWS Contrast?	N/A
N/A	Landing Slope (%)	N/A	N/A	DWS Length (in)	N/A
N/A	Landing X Slope (%)	N/A	N/A	DWS Full Width?	N/A
N/A	Landing Curb? (Y/N)	N/A	N/A	DWS Offset (in)	N/A
N/A	Shared Landing?	N/A			
N/A	Gutter Ponding?	N/A	N/A	Gutter Slope (%)	N/A
N/A	Gutter Lip Ht (in)	N/A	N/A	Gutter X Slope (%)	N/A
N/A	Painted X Walk1?	Yes	N/A	Painted X Walk2?	N/A
	X Walk 1 Direction	To NW		X Walk 2 Direction	N/A
N/A	X Walk 1 Width (in)	108.0	N/A	X Walk 2 Width (in)	N/A
	X Walk 1 Slope (%)	2.2		X Walk 2 Slope (%)	N/A
	X Walk 1 X Slope (%)	1.2		X Walk 2 X Slope (%)	N/A

N/A	Ramp inside XWalk1?	Yes	N/A	Ramp inside XWalk2?	N/A
	Road Slope (%)	N/A	N/A	Clear Space?	N/A
	Road X Slope (%)	N/A	N/A	Clear Space to XWalk (in)	N/A
N/A	Any Obstructions?	N/A	N/A	Storm Grate/Utility Hazard?	N/A
	Obstruction Type			Storm Grate/Utility Type	
		N/A			N/A
			Yes	Surface Condition? (G/P)	Good

Possible Solutions:

Remove & Replace Entire Ramp.
