# Access Compliance Report

## Public Rights-of-Way

### (Curb Ramps)

| Intersection ID: 13959 | Main Street: CLEVELAND_AV | Cross Street: E_PARK_AV | Location: S |

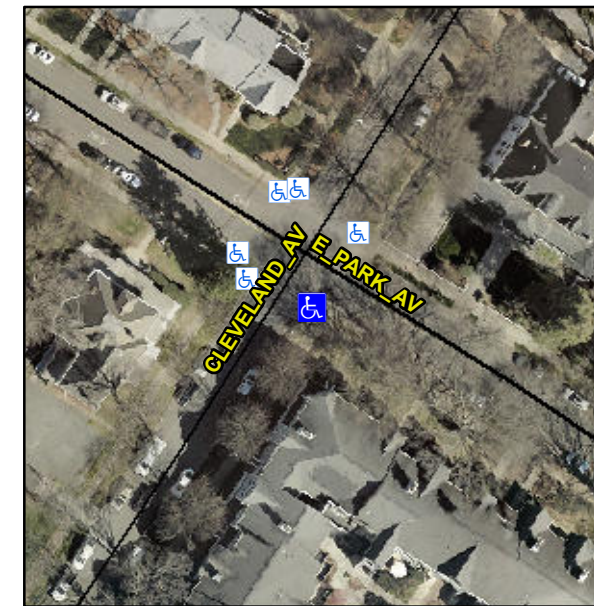
#### Field Measurements/Component Compliance

| Compliance | Description | Data | Compliance | Description | Data |
|---|---|---|---|---|---|
| No | Landing Length (in) | N/A | Yes | DWS Provided? | Yes |
| No | Landing Width (in) | N/A | Yes | DWS Contrast? | Yes |
| No | Landing Slope (%) | N/A | Yes | DWS Length (in) | 24.0 |
| No | Landing X Slope (%) | N/A | No | DWS Full Width? | No |
| No | Gutter Ponding? | Yes | Yes | Gutter Slope (%) | 1.9 |
| No | Gutter Lip Ht (in) | 1.0 | Yes | Gutter X Slope (%) | 0.8 |

**Remove & Replace Curb Ramp With Two New Directional Ramps or Equivalent. Grind Gutter Lip.**

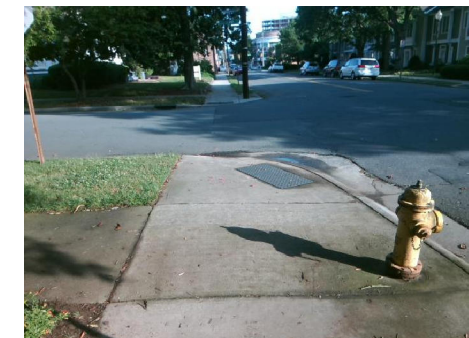
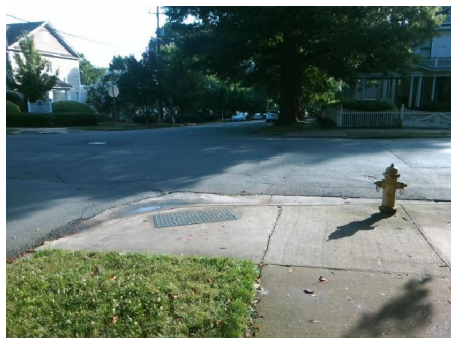
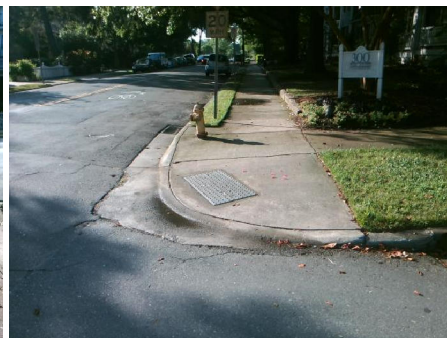
**R304.2.1, R304.2.2-Perp, R304.3.2-Para, R304.5.3, R305.1.4, R305.2, R302.7, R302.7.2**

| Compliance | Description | Data | Compliance | Description | Data |
|---|---|---|---|---|---|
| N/A | Landing Curb? (Y/N) | No | No | DWS Offset (in) | 12.0 |
