Access Compliance Report

Public Rights-of-Way

(Curb Ramps)

Intersection ID: 8847	Main Street: E_SUGAR_CREEK_RD	Cross Street: N_TRYON_ST	Location: SW
ADA ID: E43F9E161945	Ramp Type: Perp	Initial Pass/Fail: Fail	Overall Compliance: No
Severity Score: 18.75			
Codes/Mitigation Info/Possible Solution		Field Measurements/Component Compliance

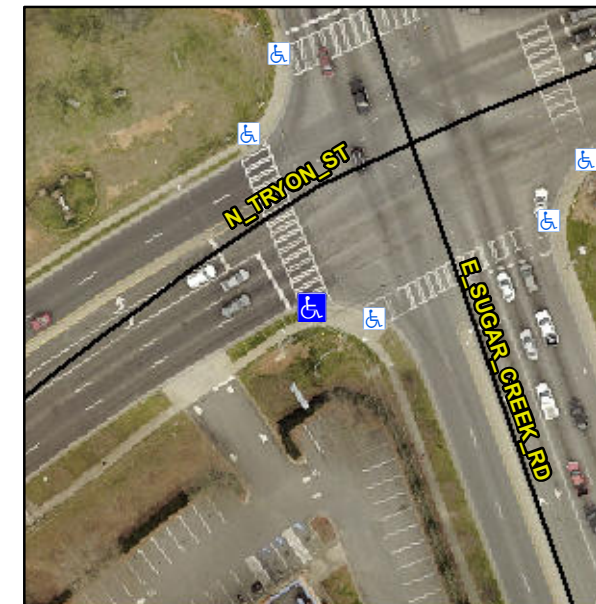
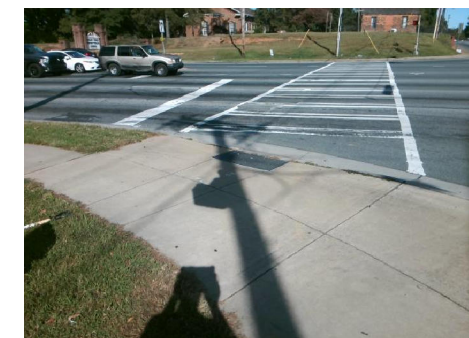
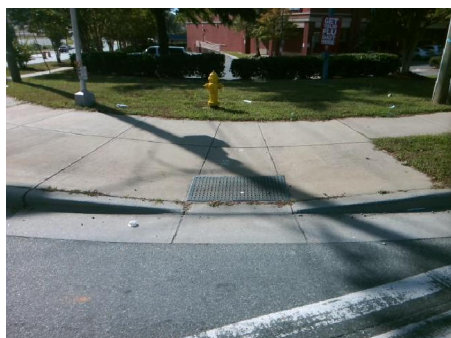
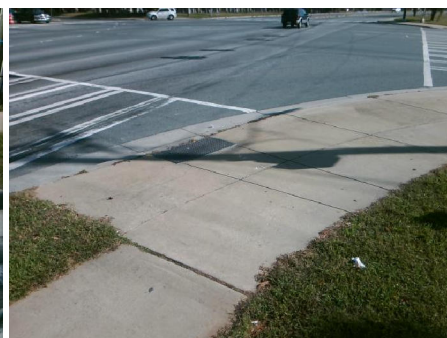
Not Found, R304.5.1, R304.5.3

Compliance	Description	Data	Compliance	Description	Data
N/A	Ramp Length (in)	68.0	Yes	Ramp Slope (%)	5.4
No	Ramp Width (in)	35.0	No	Ramp XSlope (%)	3.7
N/A	Flare Type LT	N/A	N/A	Flare Type RT	N/A
N/A	Flare Slope LT (%)	N/A	N/A	Flare Slope RT (%)	N/A
N/A	Flare Traversable LT?	N/A	N/A	Flare Traversable RT?	N/A
N/A	Landing Length (in)	N/A	N/A	DWS Provided?	N/A
N/A	Landing Width (in)	N/A	N/A	DWS Contrast?	N/A
N/A	Landing Slope (%)	N/A	N/A	DWS Length (in)	N/A
N/A	Landing X Slope (%)	N/A	N/A	DWS Full Width?	N/A
N/A	Landing Curb? (Y/N)	N/A	N/A	DWS Offset (in)	N/A
N/A	Shared Landing?	N/A			
N/A	Gutter Ponding?	N/A	N/A	Gutter Slope (%)	N/A
N/A	Gutter Lip Ht (in)	N/A	N/A	Gutter X Slope (%)	N/A
N/A	Painted X Walk1?	Yes	N/A	Painted X Walk2?	N/A
	X Walk 1 Direction	To N		X Walk 2 Direction	N/A
N/A	X Walk 1 Width (in)	178.0	N/A	X Walk 2 Width (in)	N/A
	X Walk 1 Slope (%)	1.8		X Walk 2 Slope (%)	N/A
	X Walk 1 X Slope (%)	0.1		X Walk 2 X Slope (%)	N/A

N/A	Ramp inside XWalk1?	Yes	N/A	Ramp inside XWalk2?	N/A
	Road Slope (%)	N/A	N/A	Clear Space?	N/A
	Road X Slope (%)	N/A	N/A	Clear Space to XWalk (in)	N/A
N/A	Any Obstructions?	N/A	N/A	Storm Grate/Utility Hazard?	N/A
	Obstruction Type			Storm Grate/Utility Type	
		N/A			N/A
			Yes	Surface Condition? (G/P)	Good

Remove & Replace Entire Ramp.
