## **Access Compliance Report Public Rights-of-Way** (Curb Ramps)

Intersection ID: 11458 Main Street: ASHLEY RD Cross Street: KEMPTON\_PL Location: **ADA ID: E440077D2DFD** Ramp Type: BlendTrans1 Initial Pass/Fail: Fail **Overall Compliance: No Severity Score:** 1.25

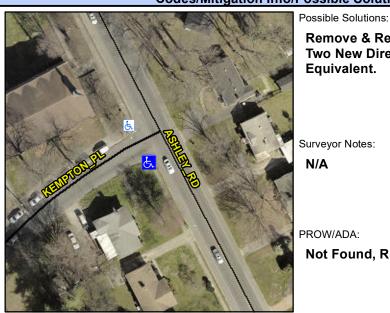
Not Found, R304.5.3

Field Measurements/Component Compliance						
Compliance Description		Data	Compl	iance	Description	Data
N/A	Ramp Length (in)	24.5	Yes	Blend	Trans Slope (%)	4.8
Yes	Ramp Width (in)	48.0	No	Blend	ITrans XSlope (%)	4.0
N/A	Flare Type LT	N/A	N/A	Flare	Type RT	N/A
N/A	Flare Slope LT (%)	N/A	N/A	Flare	Slope RT (%)	N/A
N/A	Flare Traversable LT?	N/A	N/A	Flare	Traversable RT?	N/A
N/A	Landing Length (in)	N/A	N/A	DWS	Provided?	N/A
N/A	Landing Width (in)	N/A	N/A	DWS	Contrast?	N/A
N/A	Landing Slope (%)	N/A	N/A	DWS	Length (in)	N/A
N/A	Landing X Slope (%)	N/A	N/A	DWS	Full Width?	N/A
N/A	Landing Curb? (Y/N)	N/A	N/A	DWS	Offset (in)	N/A
N/A	Shared Landing?	N/A				
N/A	Gutter Ponding?	N/A	N/A	Gutte	er Slope (%)	N/A
N/A	Gutter Lip Ht (in)	N/A	N/A	Gutte	er X Slope (%)	N/A
N/A	Painted X Walk1?	No	N/A	Paint	ed X Walk2?	N/A
	X Walk 1 Direction	To NW		X Wa	lk 2 Direction	N/A
	X Walk 1 Width (in)	N/A		X Wa	lk 2 Width (in)	N/A
	X Walk 1 Slope (%)	2.6		X Wa	lk 2 Slope (%)	N/A

X Walk 1 X Slope (%)	1.2		X Wa	lk 2 X Slope (%)	N/A
N/A	Ramp inside XWalk1?	N/A	N/A	Ram	inside XWalk2?	N/A
	Road Slope (%)	1.2		Clear	Space?	N/A
	Road X Slope (%)	2.6	N/A	Clear	Space to XWalk (in)	N/A
N/A	Any Obstructions?	N/A	N/A	Storn	n Grate/Utility Hazard?	N/A
	Obstruction Type			Storn	n Grate/Utility Type	
		N/A				N/A
			Yes	Surfa	ce Condition? (G/P)	Good
			No	Curb	Slope (%)	13.9

**KEMPTON PL** Street 1 Name Stop Condition-Street 1 StopSign Street 2 Name N/A Stop Condition-Street 2 N/A **Remove & Replace Curb Ramp With Two New Directional Ramps or** Equivalent.
