Access Compliance Report

Public Rights-of-Way

(Curb Ramps)

Intersection ID: 3205	Main Street: LANSHIRE_CT	Cross Street: SHELLY_PINES_DR	Location: NW
ADA ID: E450ADFC7962	Ramp Type: Perp	Initial Pass/Fail: Fail	Overall Compliance: No
		Severity Score: 25

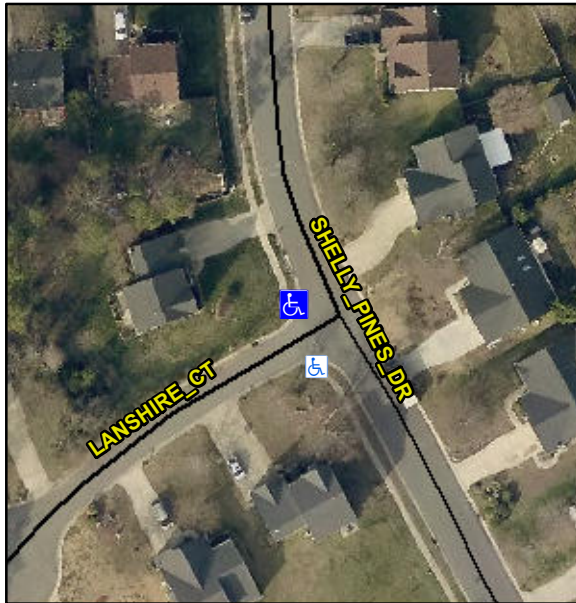
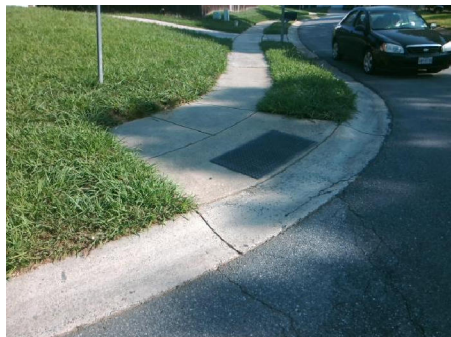
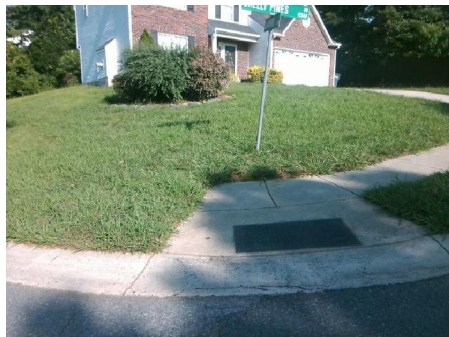
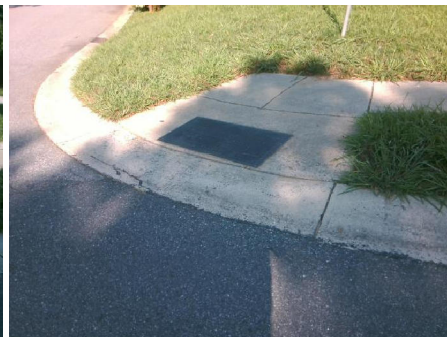
Not Found, R304.5.3

Compliance	Description	Data	Compliance	Description	Data
N/A	Ramp Length (in)	46.0	Yes	Ramp Slope (%)	8.3
Yes	Ramp Width (in)	60.0	No	Ramp XSlope (%)	8.5
N/A	Flare Type LT	N/A	N/A	Flare Type RT	N/A
N/A	Flare Slope LT (%)	N/A	N/A	Flare Slope RT (%)	N/A
N/A	Flare Traversable LT?	N/A	N/A	Flare Traversable RT?	N/A
N/A	Landing Length (in)	N/A	N/A	DWS Provided?	N/A
N/A	Landing Width (in)	N/A	N/A	DWS Contrast?	N/A
N/A	Landing Slope (%)	N/A	N/A	DWS Length (in)	N/A
N/A	Landing X Slope (%)	N/A	N/A	DWS Full Width?	N/A
N/A	Landing Curb? (Y/N)	N/A	N/A	DWS Offset (in)	N/A
N/A	Shared Landing?	N/A			
N/A	Gutter Ponding?	N/A	N/A	Gutter Slope (%)	N/A
N/A	Gutter Lip Ht (in)	N/A	N/A	Gutter X Slope (%)	N/A
N/A	Painted X Walk1?	No	N/A	Painted X Walk2?	N/A
	X Walk 1 Direction	To S		X Walk 2 Direction	N/A
N/A	X Walk 1 Width (in)	N/A	N/A	X Walk 2 Width (in)	N/A
	X Walk 1 Slope (%)	6.3		X Walk 2 Slope (%)	N/A
	X Walk 1 X Slope (%)	2.1		X Walk 2 X Slope (%)	N/A

N/A	Ramp inside XWalk1?	N/A	N/A	Ramp inside XWalk2?	N/A
	Road Slope (%)	N/A	N/A	Clear Space?	N/A
	Road X Slope (%)	N/A	N/A	Clear Space to XWalk (in)	N/A
N/A	Any Obstructions?	N/A	N/A	Storm Grate/Utility Hazard?	N/A
	Obstruction Type			Storm Grate/Utility Type	
		N/A			N/A
			Yes	Surface Condition? (G/P)	Good

Possible Solutions:

Remove & Replace Entire Ramp.
