# Access Compliance Report

## Public Rights-of-Way

### (Curb Ramps)

Intersection ID: N/A	Main Street: MORABLIN_DR	Cross Street: CORLISS_AV	Location: N
ADA ID: E45505D2474A	Ramp Type: PerpDiag	Initial Pass/Fail: Fail	Overall Compliance: No
		Severity Score: 60

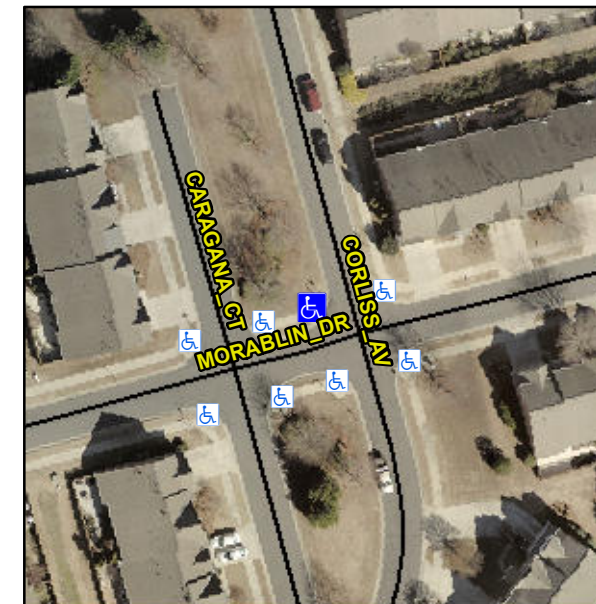
**Not Found, R304.5.1, R304.5.3**

Compliance	Description	Data	Compliance	Description	Data
N/A	Ramp Length (in)	97.0	Yes	Ramp Slope (%)	5.5
No	Ramp Width (in)	27.0	No	Ramp XSlope (%)	10.2
N/A	Flare Type LT	N/A	N/A	Flare Type RT	N/A
N/A	Flare Slope LT (%)	N/A	N/A	Flare Slope RT (%)	N/A
N/A	Flare Traversable LT?	N/A	N/A	Flare Traversable RT?	N/A
N/A	Landing Length (in)	N/A	N/A	DWS Provided?	N/A
N/A	Landing Width (in)	N/A	N/A	DWS Contrast?	N/A
N/A	Landing Slope (%)	N/A	N/A	DWS Length (in)	N/A
N/A	Landing X Slope (%)	N/A	N/A	DWS Full Width?	N/A
N/A	Landing Curb? (Y/N)	N/A	N/A	DWS Offset (in)	N/A
N/A	Shared Landing?	N/A			
N/A	Gutter Ponding?	N/A	N/A	Gutter Slope (%)	N/A
N/A	Gutter Lip Ht (in)	N/A	N/A	Gutter X Slope (%)	N/A
N/A	Painted X Walk1?	No	N/A	Painted X Walk2?	No
	X Walk 1 Direction	To S		X Walk 2 Direction	To E
N/A	X Walk 1 Width (in)	N/A	N/A	X Walk 2 Width (in)	N/A
	X Walk 1 Slope (%)	3.1		X Walk 2 Slope (%)	3.5
	X Walk 1 X Slope (%)	6.0		X Walk 2 X Slope (%)	6.5

N/A	Ramp inside XWalk1?	N/A	N/A	Ramp inside XWalk2?	N/A
	Road Slope (%)	8.0	N/A	Clear Space?	N/A
	Road X Slope (%)	0.8	N/A	Clear Space to XWalk (in)	N/A
N/A	Any Obstructions?	N/A	N/A	Storm Grate/Utility Hazard?	N/A
	Obstruction Type			Storm Grate/Utility Type	
		N/A			N/A
			Yes	Surface Condition? (G/P)	Good

**Remove & Replace Curb Ramp With Two New Directional Ramps or Equivalent.**
