Access Compliance Report

Public Rights-of-Way

(Curb Ramps)

Intersection ID: 10038802	Main Street: STEELE_CREEK_RD	Cross Street: N/A	Location: NE
ADA ID: E45EEF0BB794	Ramp Type: BlendTrans1	Initial Pass/Fail: Fail	Overall Compliance: No
Severity Score: 10			
Codes/Mitigation Info/Possible Solution		Field Measurements/Component Compliance

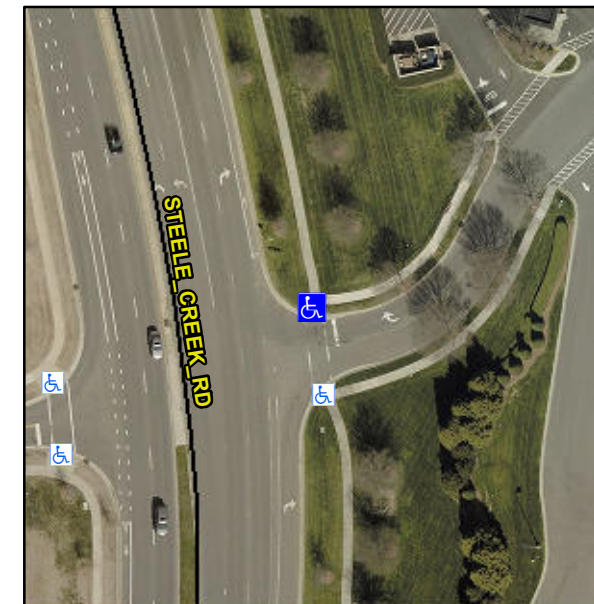
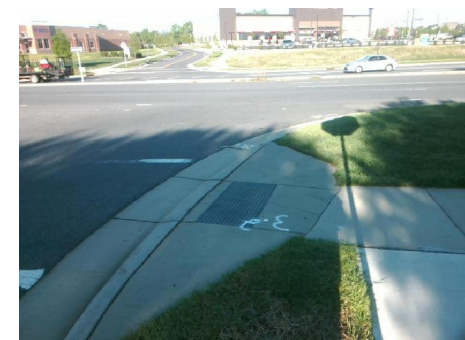
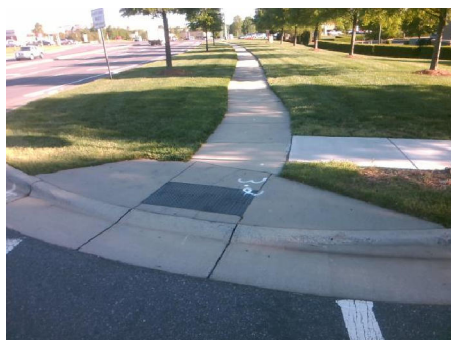
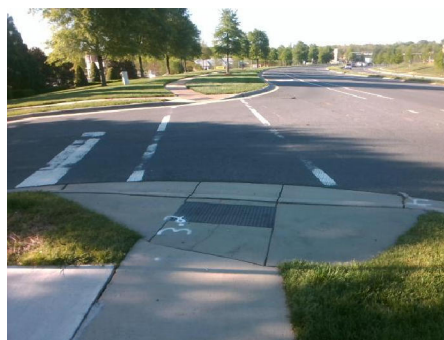
Not Found, R304.5.1, R304.5.3

Compliance	Description	Data	Compliance	Description	Data
N/A	Ramp Length (in)	56.0	Yes	BlendTrans Slope (%)	1.0
No	Ramp Width (in)	47.0	No	BlendTrans XSlope (%)	2.8
N/A	Flare Type LT	N/A	N/A	Flare Type RT	N/A
N/A	Flare Slope LT (%)	N/A	N/A	Flare Slope RT (%)	N/A
N/A	Flare Traversable LT?	N/A	N/A	Flare Traversable RT?	N/A
N/A	Landing Length (in)	N/A	N/A	DWS Provided?	N/A
N/A	Landing Width (in)	N/A	N/A	DWS Contrast?	N/A
N/A	Landing Slope (%)	N/A	N/A	DWS Length (in)	N/A
N/A	Landing X Slope (%)	N/A	N/A	DWS Full Width?	N/A
N/A	Landing Curb? (Y/N)	N/A	N/A	DWS Offset (in)	N/A
N/A	Shared Landing?	N/A			
N/A	Gutter Ponding?	N/A	N/A	Gutter Slope (%)	N/A
N/A	Gutter Lip Ht (in)	N/A	N/A	Gutter X Slope (%)	N/A
N/A	Painted X Walk1?	No	N/A	Painted X Walk2?	Yes
	X Walk 1 Direction	To W		X Walk 2 Direction	To S
	X Walk 1 Width (in)	N/A		X Walk 2 Width (in)	113.0
	X Walk 1 Slope (%)	0.1		X Walk 2 Slope (%)	1.5
	X Walk 1 X Slope (%)	0.4		X Walk 2 X Slope (%)	0.2

N/A	Ramp inside XWalk1?	N/A	N/A	Ramp inside XWalk2?	Yes
	Road Slope (%)	0.6		Clear Space?	N/A
	Road X Slope (%)	0.0	N/A	Clear Space to XWalk (in)	N/A
N/A	Any Obstructions?	N/A	N/A	Storm Grate/Utility Hazard?	N/A
	Obstruction Type			Storm Grate/Utility Type	
		N/A			N/A
			Yes	Surface Condition? (G/P)	Good
			No	Curb Slope (%)	18.7

Remove & Replace Curb Ramp With Two New Directional Ramps or Equivalent.
